# **Project „JoinTec“**

## **Application of the polyurethane solution adhesive**

**Dr.-Ing. Wilko Flügge**

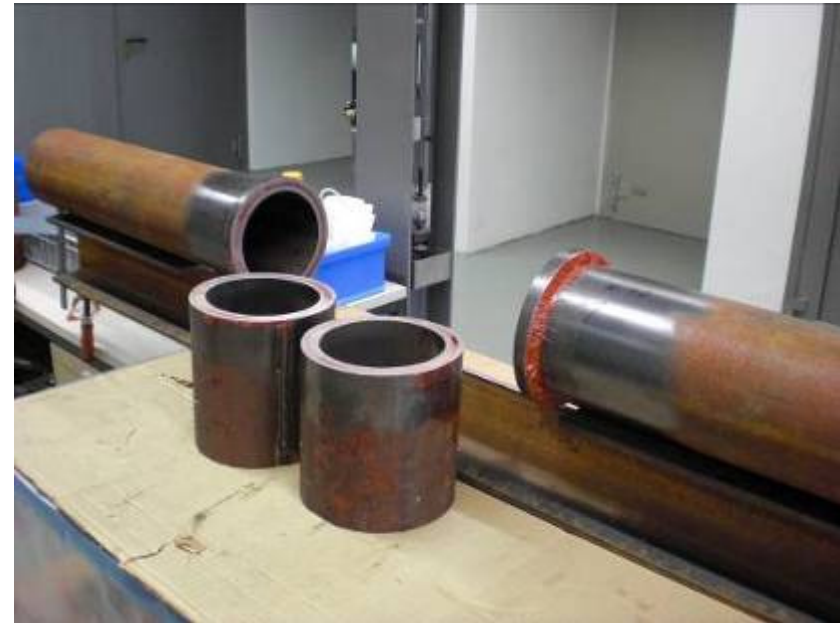
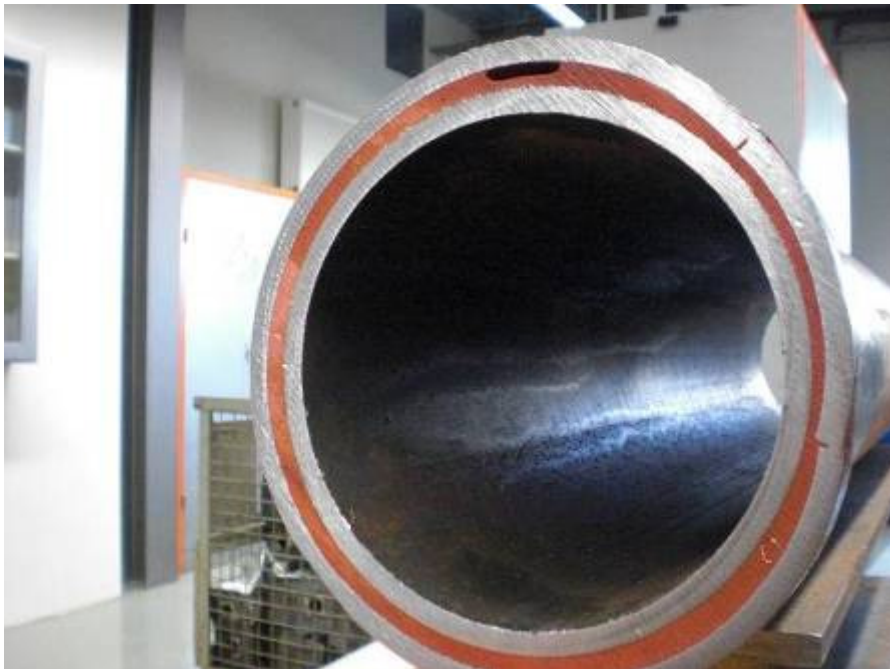
**First sample cutted in four pieces**

**Discovered defects**

- ▶ Air bubble at the top of pipe
- ▶ uncylindrical adhesive layer

**Problem solution**

- ▶ expansion reservoir on top
- ▶ equipment for bulging / fitted pipes

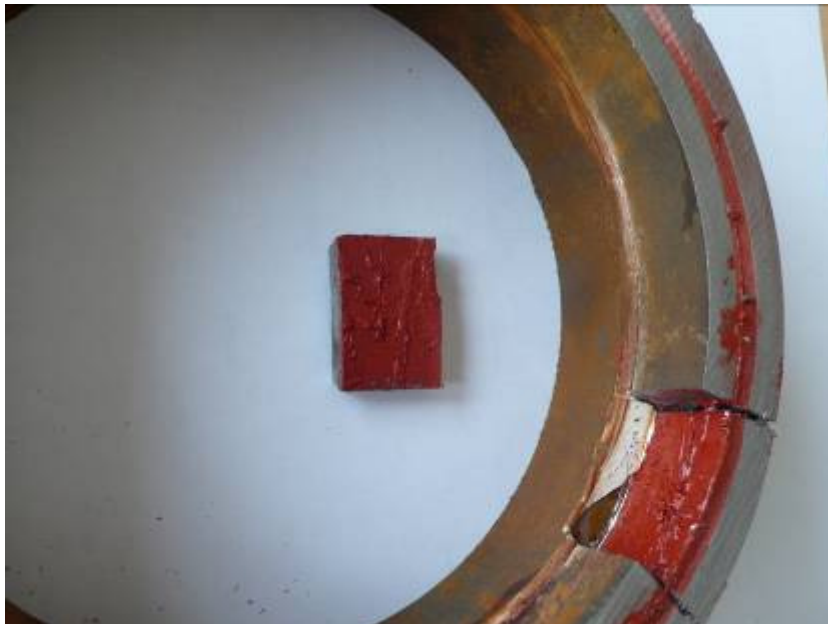
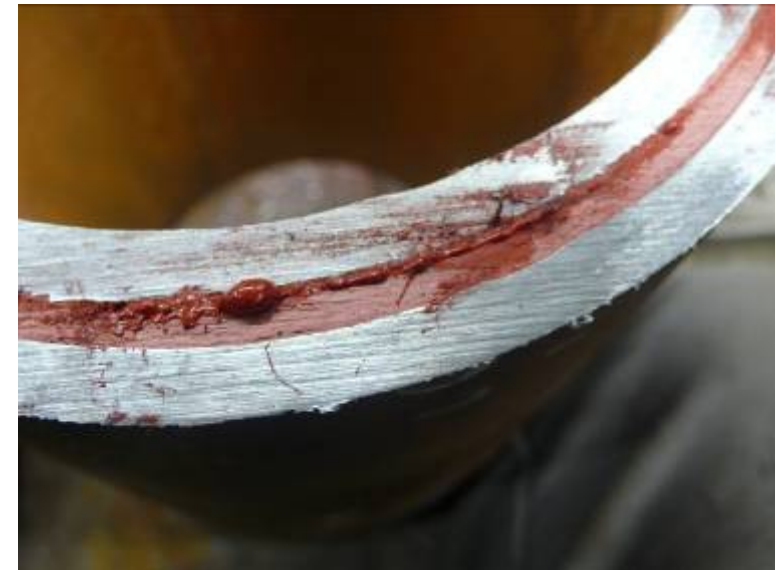
### ➤ Second and third sample at first bursting test, afterwards cutted

### ➤ Discovered defects

- just 86bar(1250psi) and 60bar(870psi) collapse pressure
- not cured layer in adhesive (cause of separated resin component)

### ➤ Problem solution

- machinal mixing of resin component in canister
- machinal mixing of resin and hardener

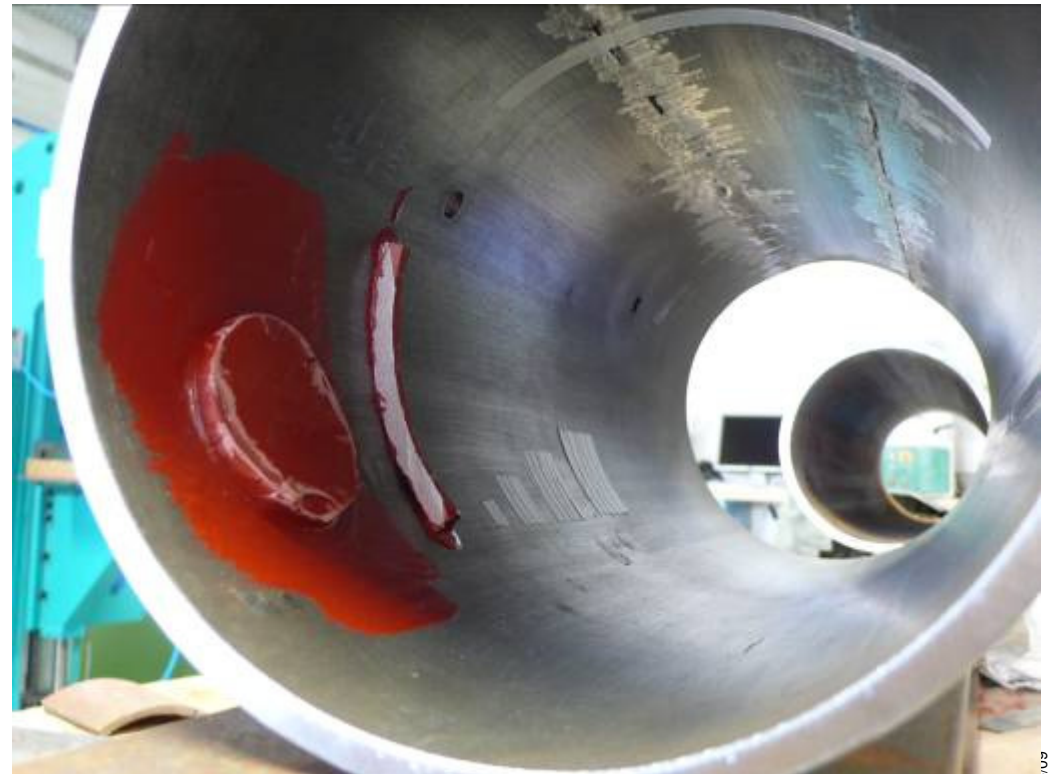
### Simulated failure

- ▶ air bubble (diameter 40mm)
- ▶ adhesion failure on sleeve and pipe surface (à four teflon squars 10x10, 20x20, 30x30, 40x40)
- ▶ adhesion failure over weld seam (one teflonstrip 10x130)
- ▶ cohesion draft between sleeve and pipe (teflonstrip 5x90)
