JoinTec

Paderborn, den 25. Mai 2010

Leaking pipe joints

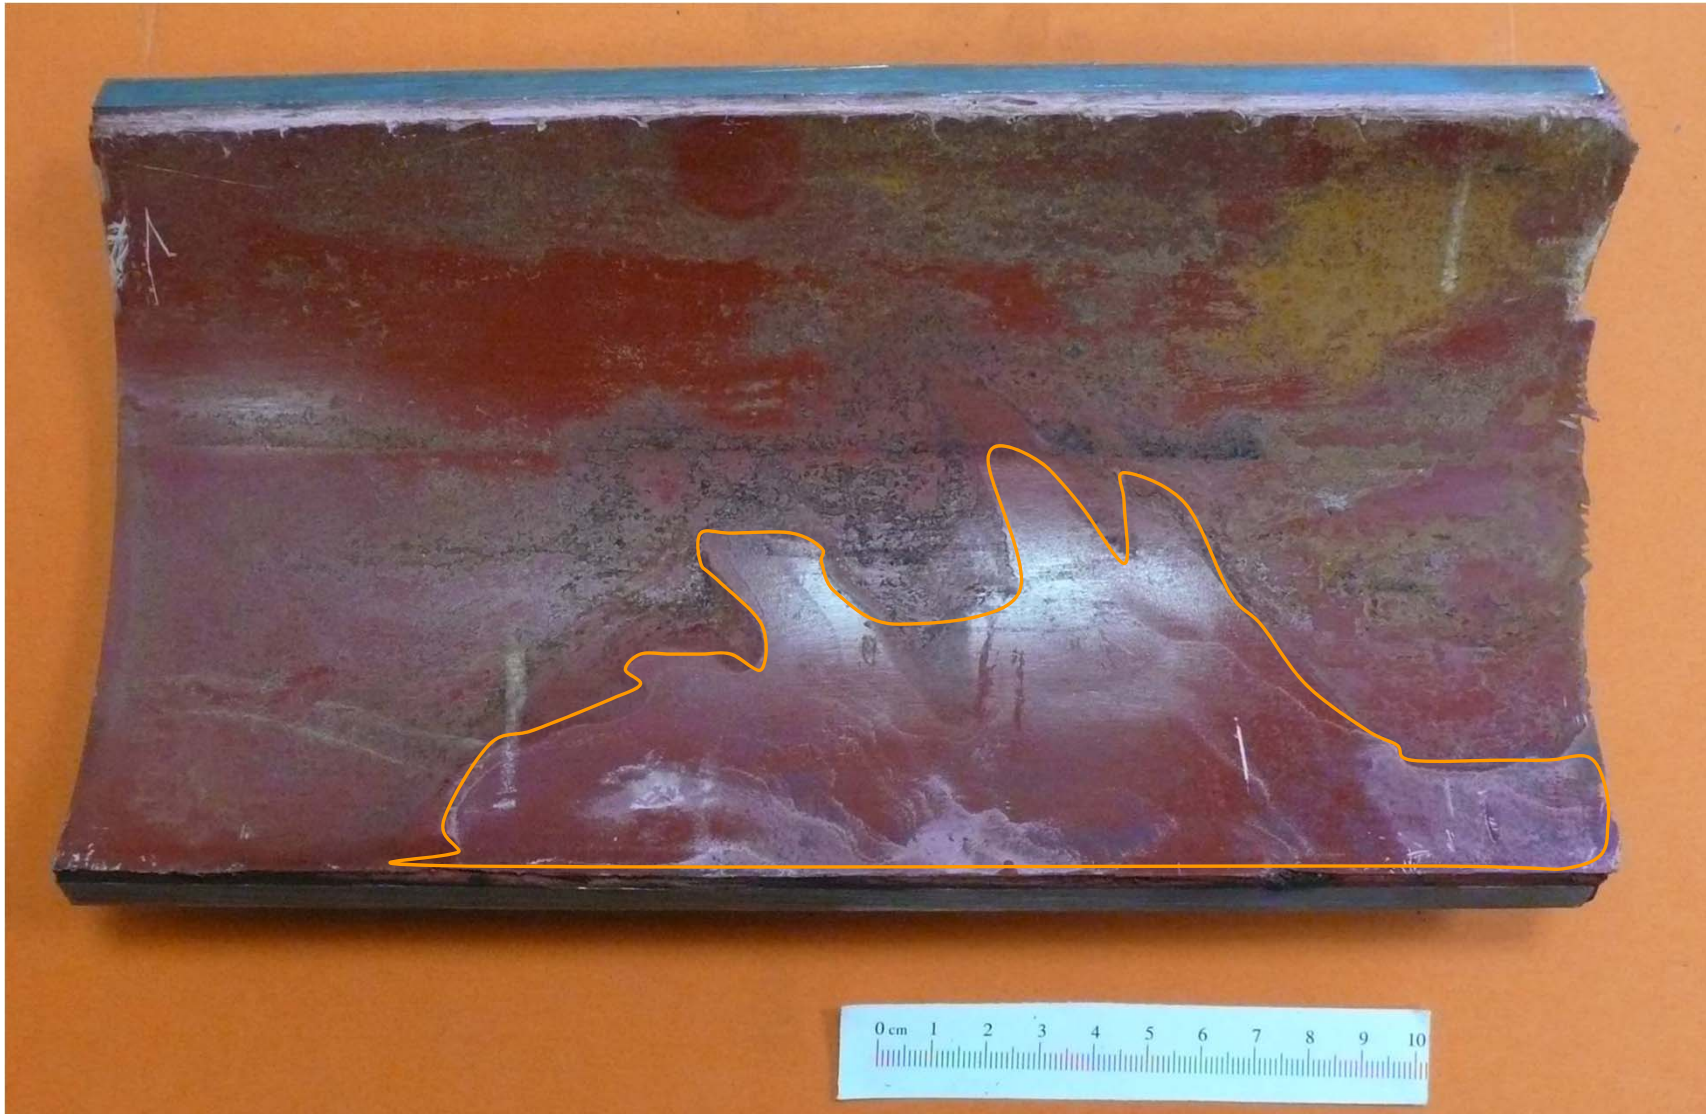
Appearance of fracture of pipe bonds with defects

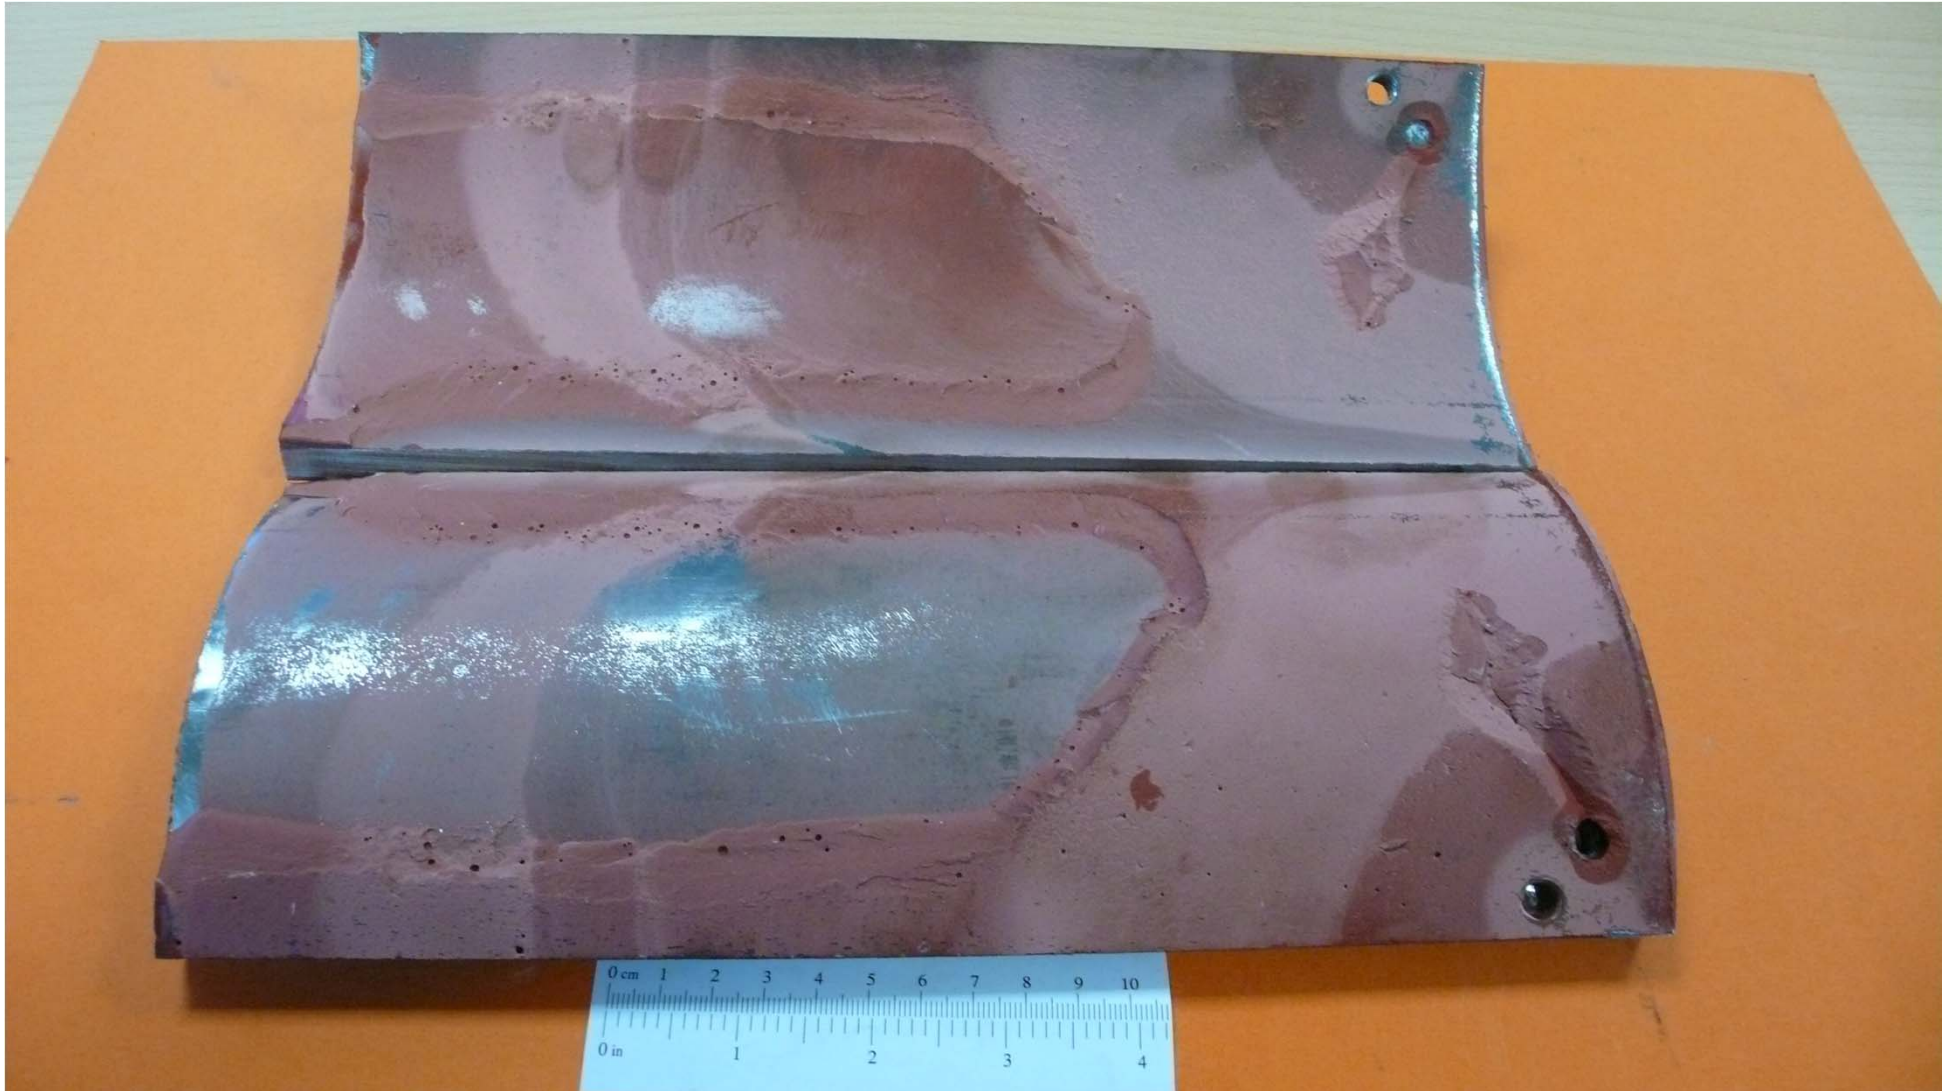
Appearance of fracture of pipe bonds without failure

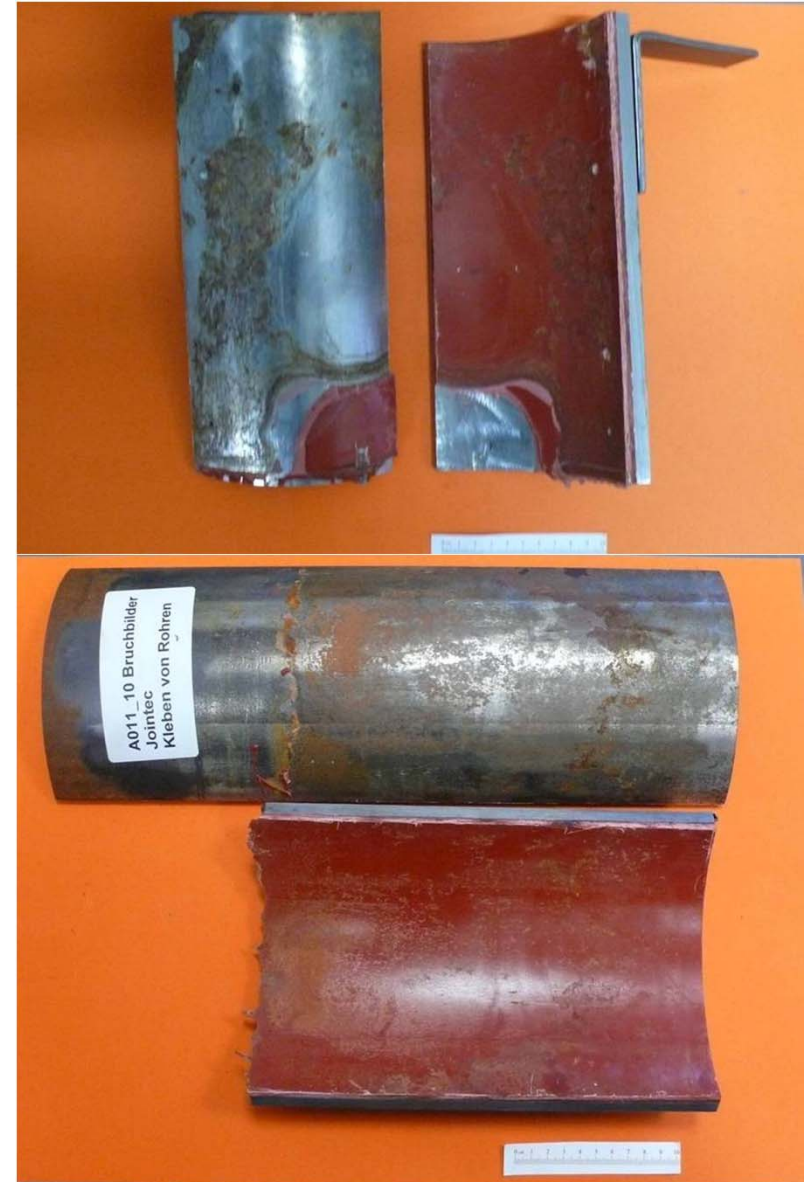
- ▶ **No adhesion between adhesive and pipe surface**
- ▶ **Water damage on the surface**
- ▶ **Mostly no adhesion on the pipe side but on the sleeve side**

Possible explanations for the phenomena of no adhesion at the pipeline sided bond line are:

- ▶ Adhesive shrinkage
- ▶ Handling issues through rotation
- ▶ Possible crack at the bond line

Unfortunately the tests do not show some shrinkage either a crack, probably because of the adhesive quantity. New tests are coming with some other preparation.

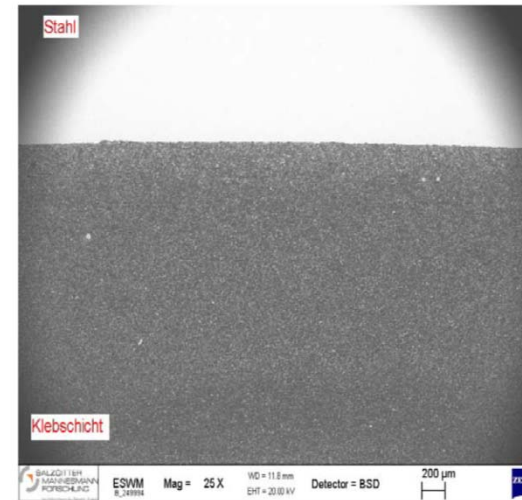
Bild 2
B_249994
Bereich 1
Keine Poren oder Risse in der Klebschicht erkennbar.

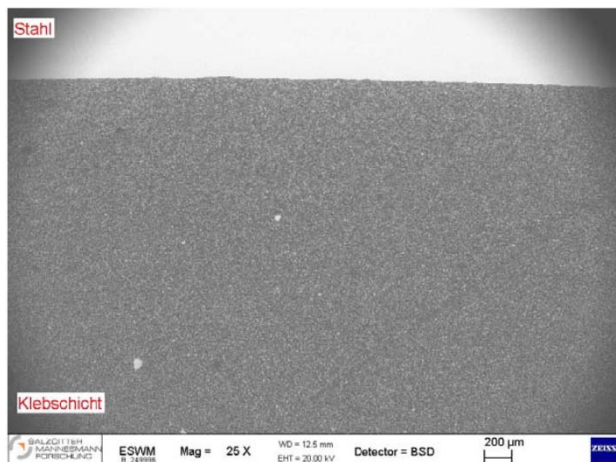
Bild 5
B_249996
Bereich 3
Keine Poren oder Risse in der Klebschicht erkennbar.

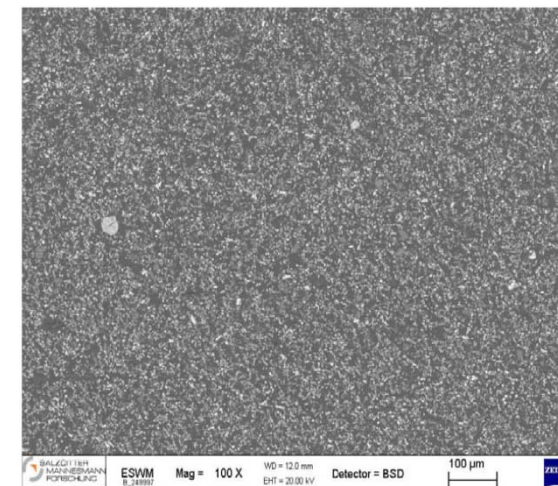
Bild 4
B_249997
Detail 2
Darstellung der Klebschicht

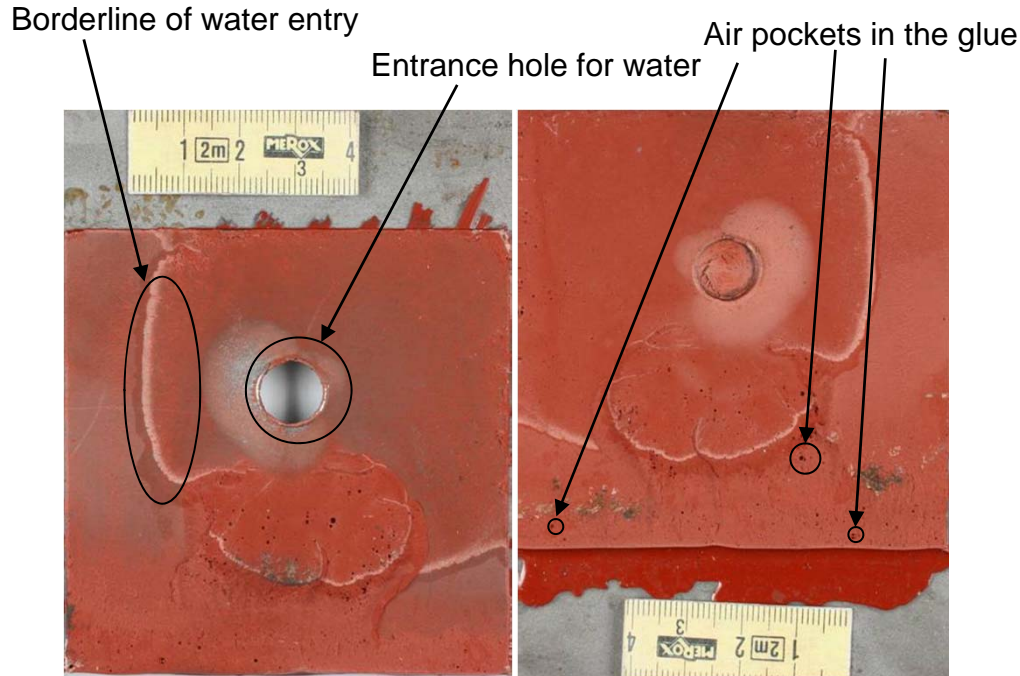
test 1: leak at 180 bar

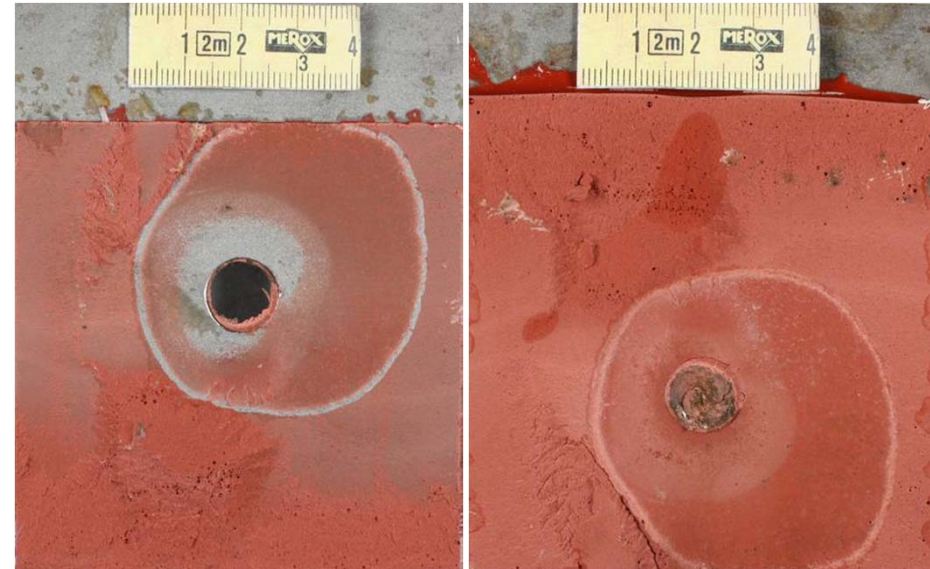
test 2: no leak at 300 bar

- Damages forced by water are not the same compared to damages at pipes
- Pressure higher as 300 bar was possible
- No „scalpel effect“

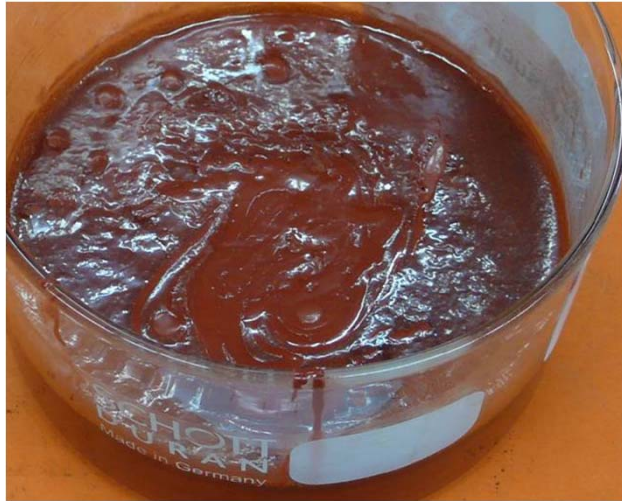
mixture after 1 day

- After 1 day: building of a hard surface
- After 6 day: liquid isocyanides is leaking out of the surface
- After 2 weeks:
 - Removing of the glass
 - Polyol next to the glass still liquid
 - Liquid isocyanides is crystalline

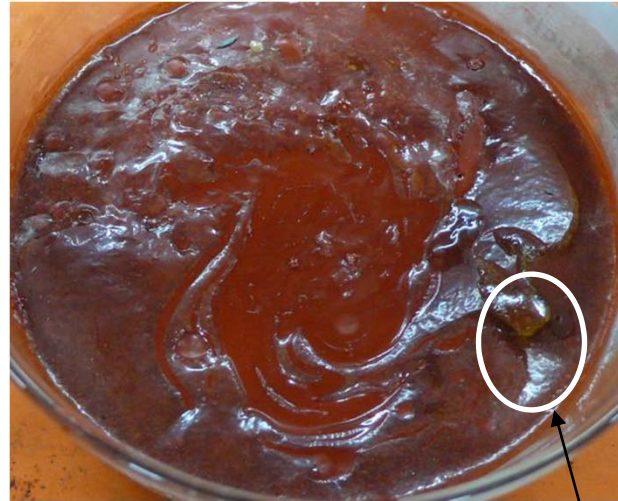
mixture after 6 days

liquid Isocyanides

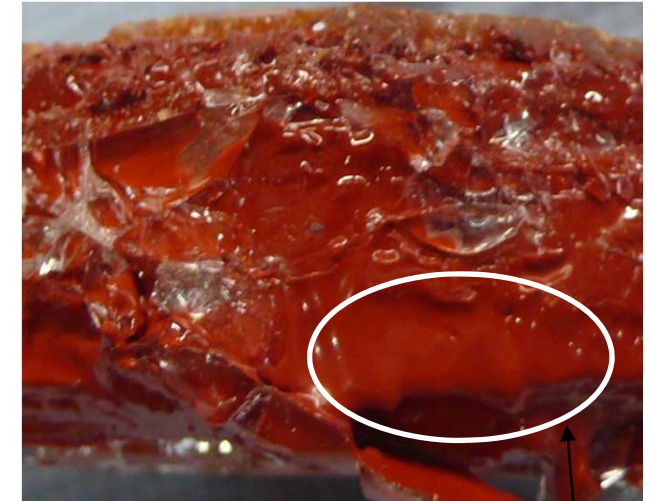
mixture after 2 weeks

liquid Polyol
