Ultrasonic Inspection of adhesively bonded Joints

M. Kaack, Th. Orth

Paderborn , 26th / 27th of May 2010

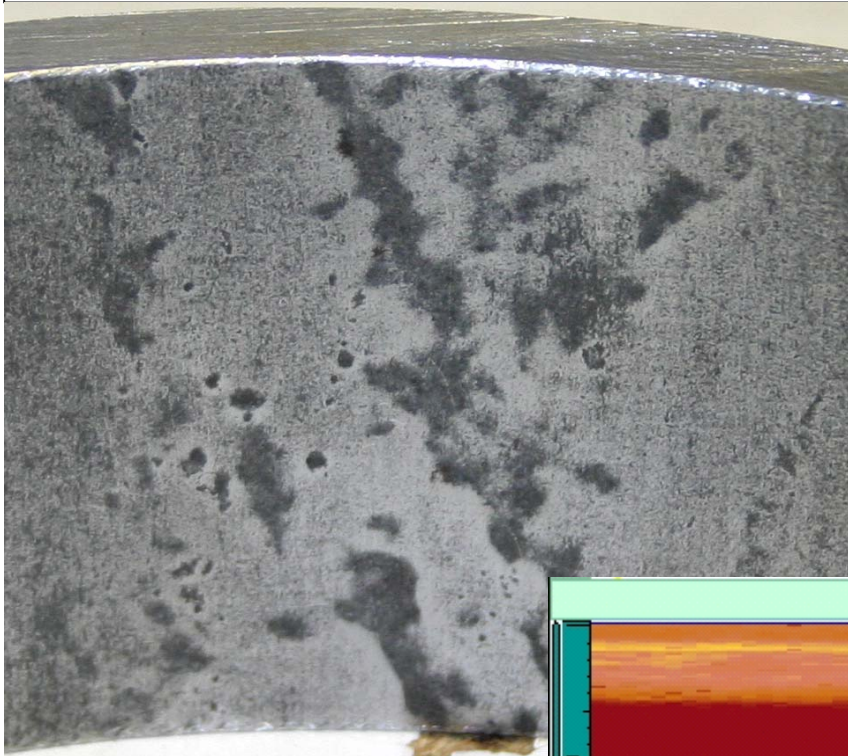
Investigation of sleeves

- Sleeves for 168 mm tubes have a 'corrosion line' opposite to the weld seam.
- These both lines lead always to UT-indications!

- To be placed in 3 o'clock and 9 o'clock positions.

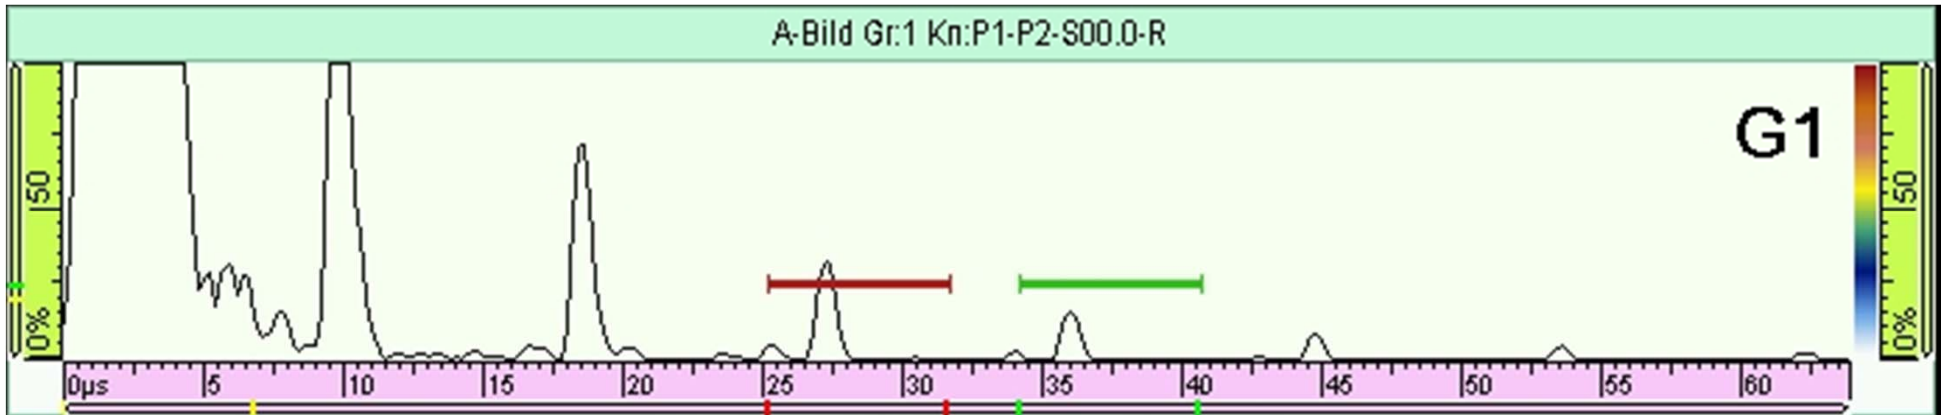
Results Joint I

- For the inspection of the large diameter joints, the 3rd to 6th echos were used.
- Typically higher echo number gives better contrast.
- Geometry of the sleeves was not perfect: seamless tube produced in a hot Pilger-process
- Wall thickness variations, ovality, excentricity,...led to variations in the echo amplitudes
- Absolute value of wall thickness is larger for this sleeve.

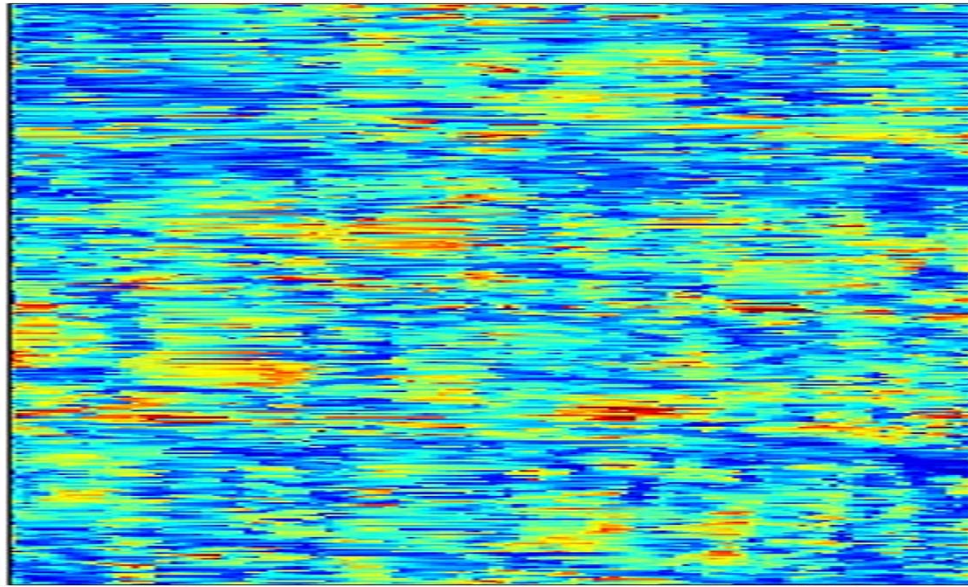
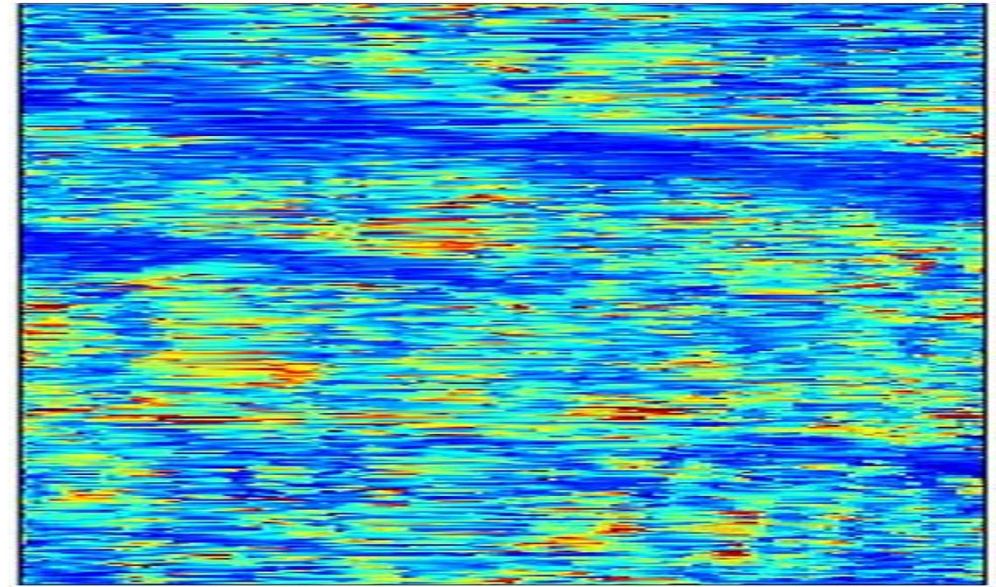
Results Joint III

- Done by manual inspection.
- No indication for air void found.
- No liquid adhesive found.

- A reference defect would have been necessary to evaluate the technique under the changed conditions.

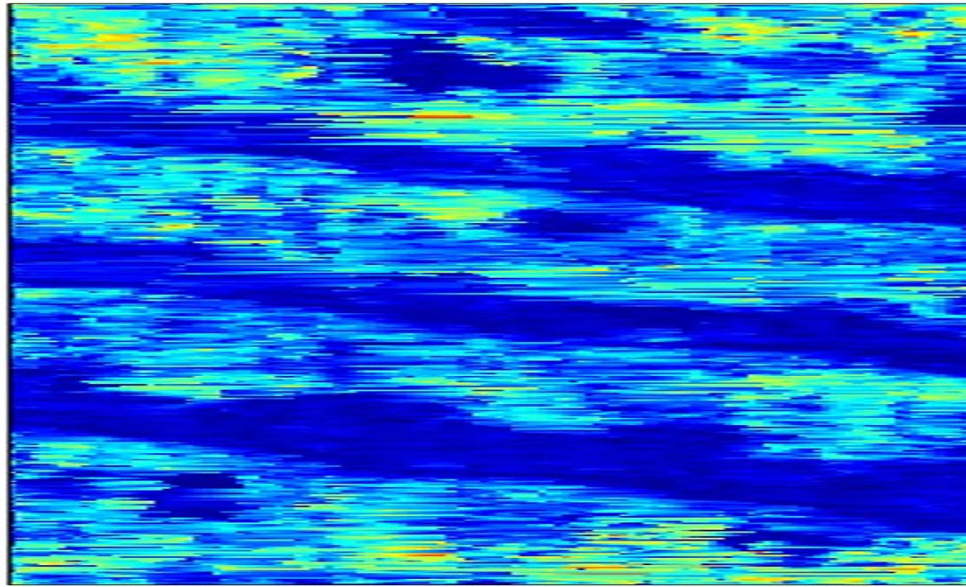
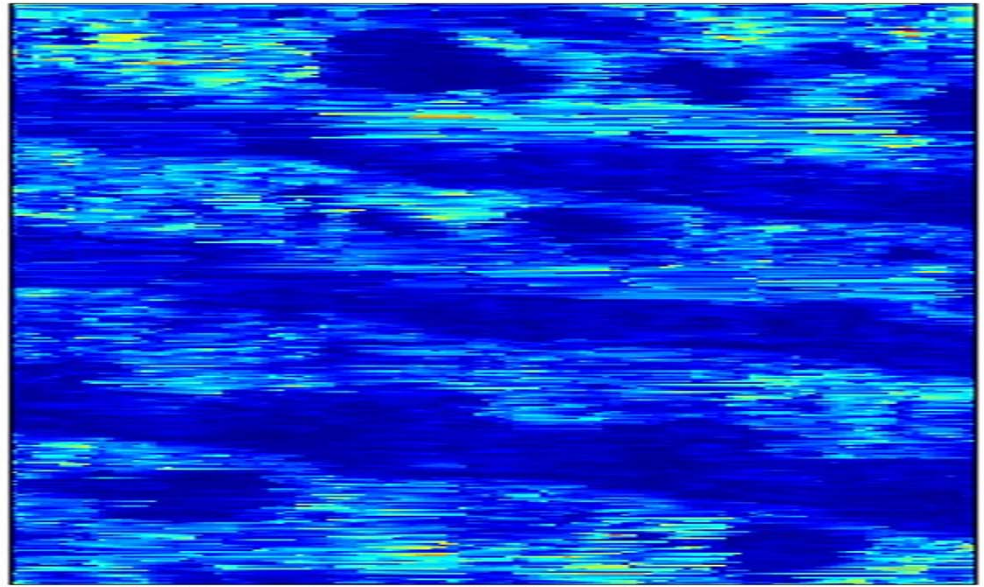
Results Joint VI

- Done by manual inspection.
- No indication for air void found.
- No liquid adhesive found.

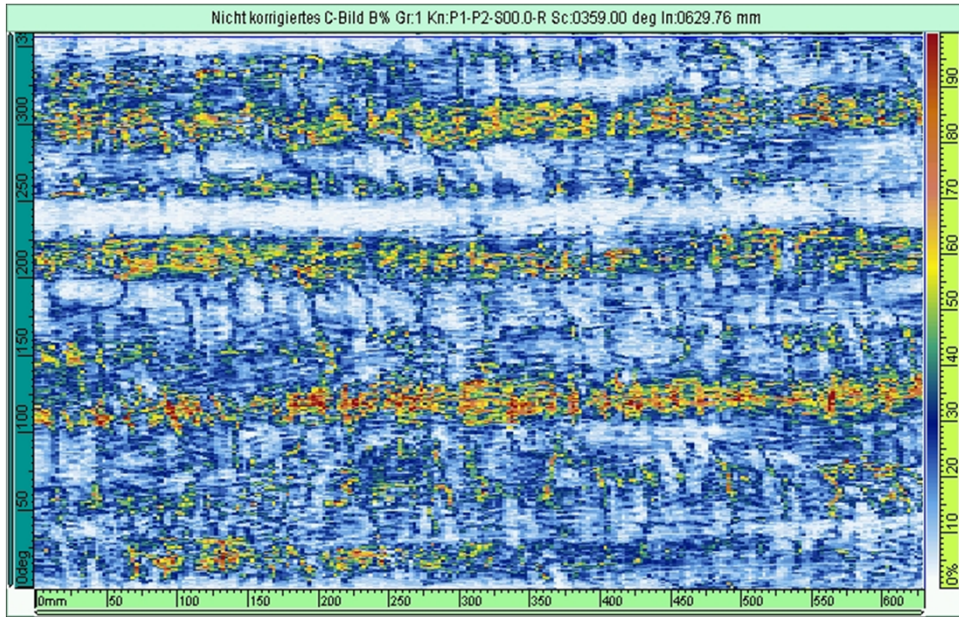
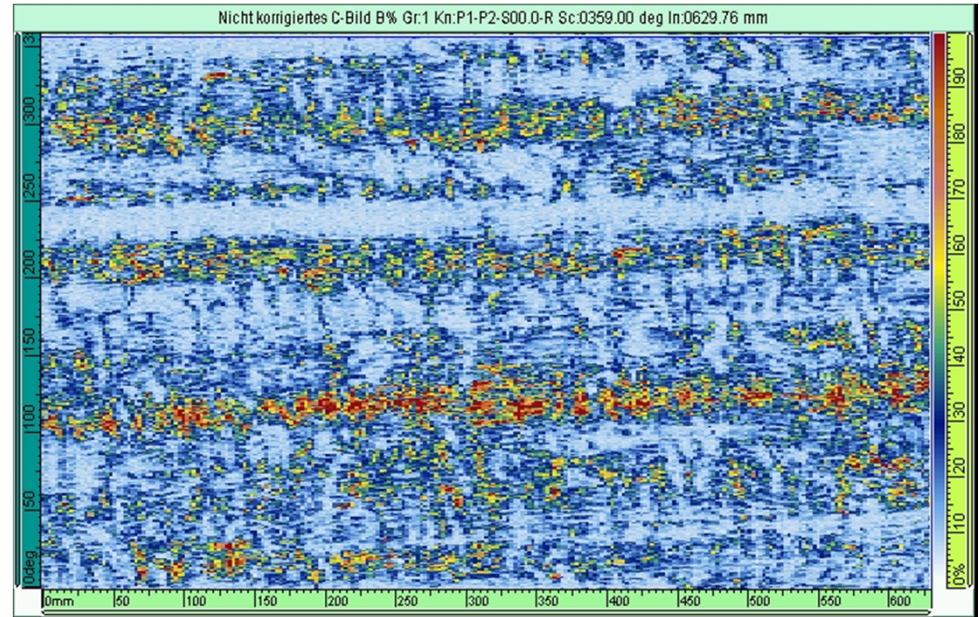
Results Joint I

- Done by **automatic inspection**.
- No indication for air void found.
- Liquid adhesive found.

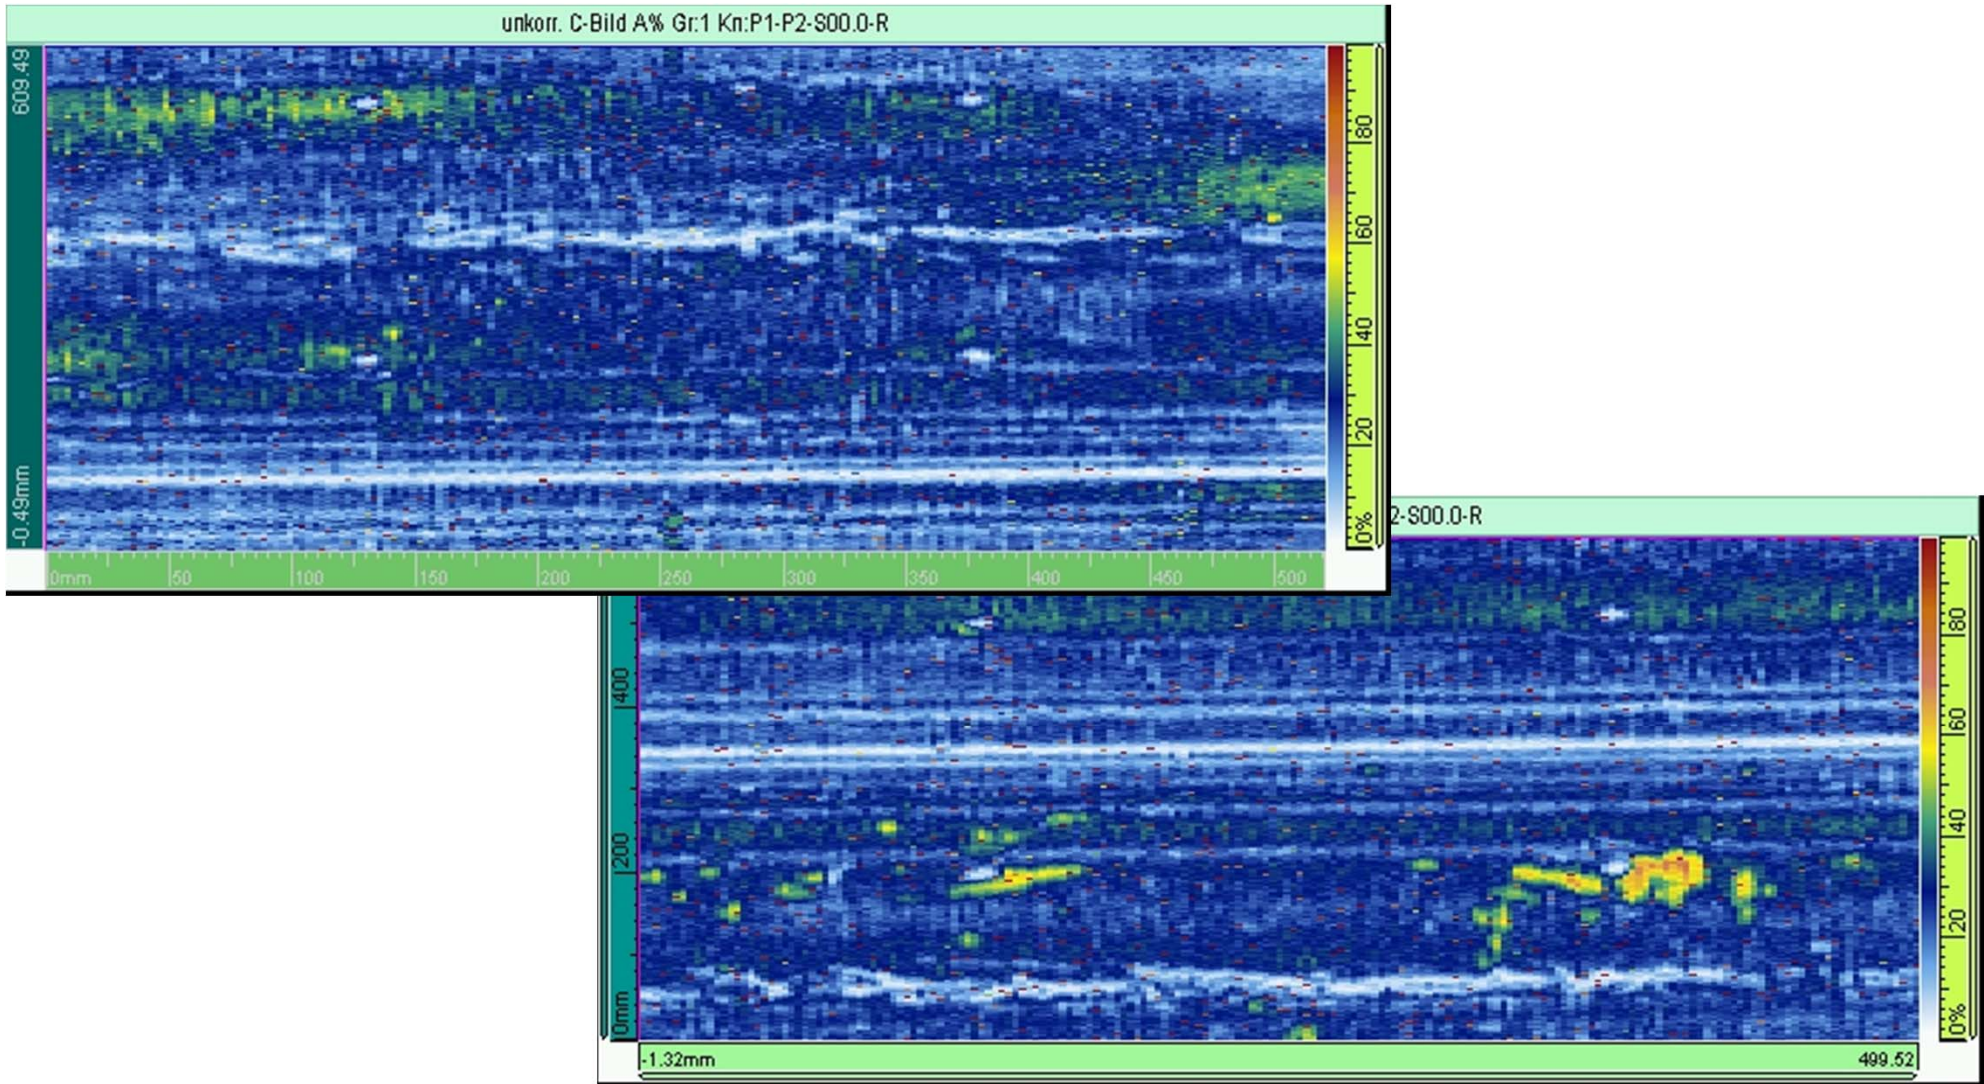
Results of inspection of bonded joints (168 mm tubes) before destructive testing.

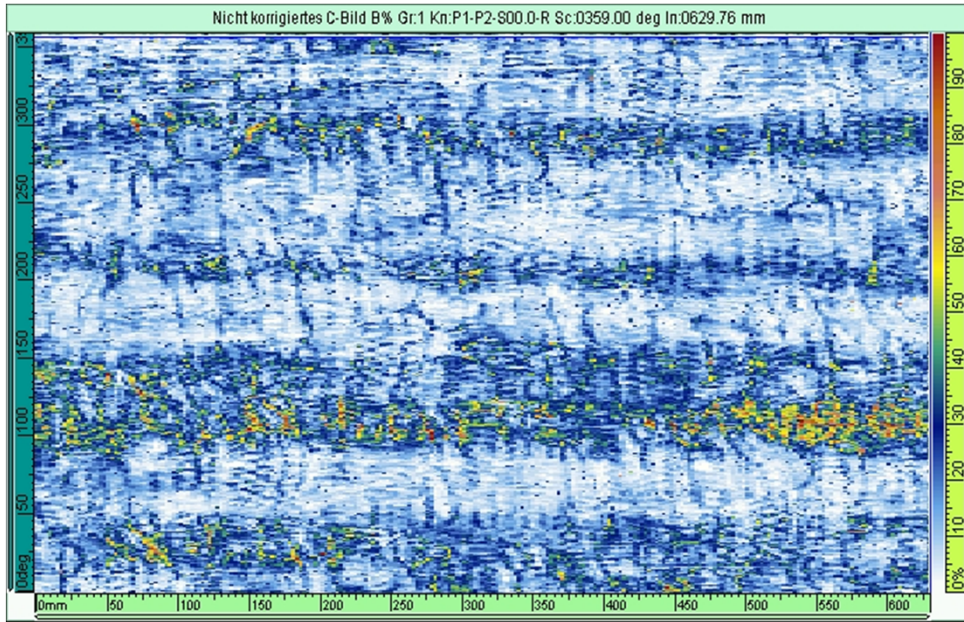
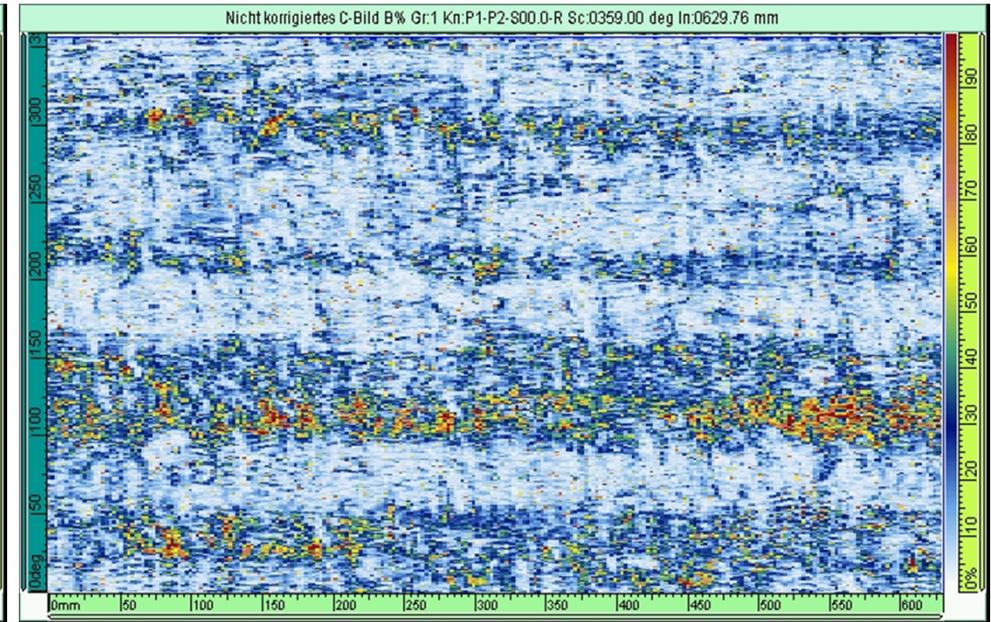
Results Joint II

- Done by automatic inspection.
- No indication for air void found.
- Liquid adhesive found.

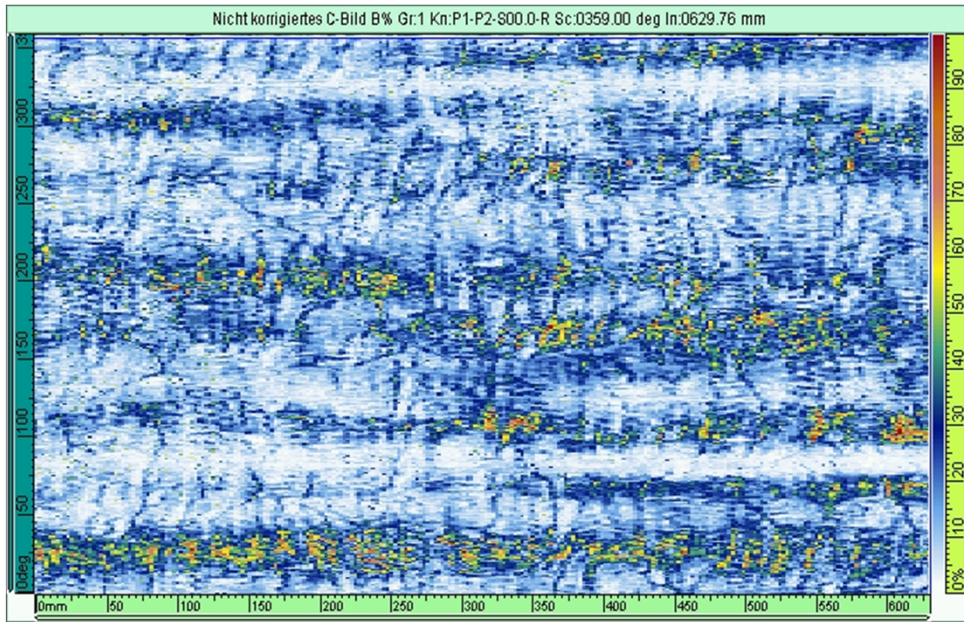
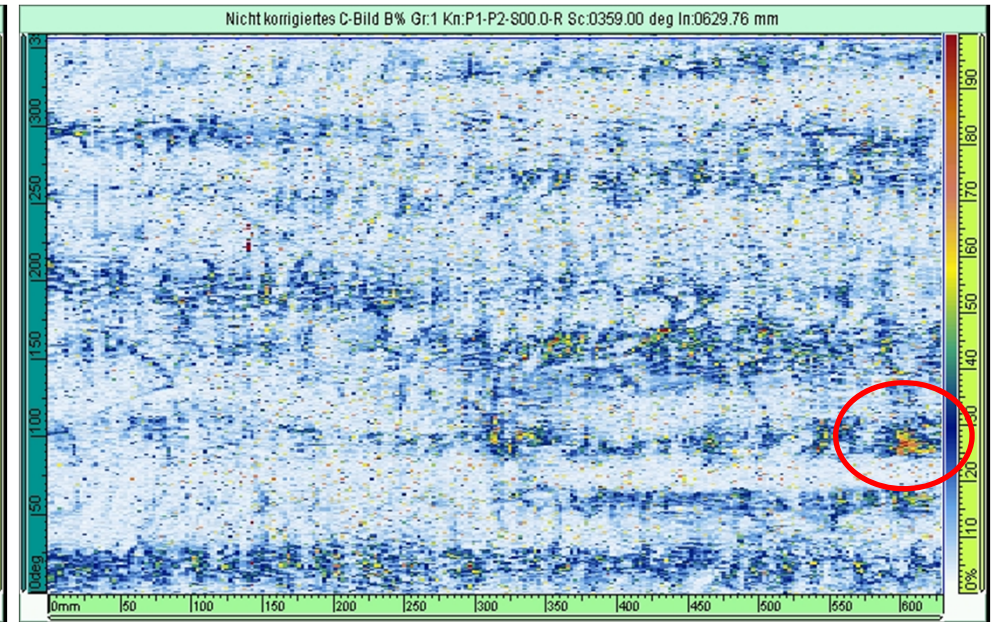
Results Joint IV

- Done by automatic inspection.
- Indication for air void found in the position of the filling holes. → *Feedback*
- No liquid adhesive found.

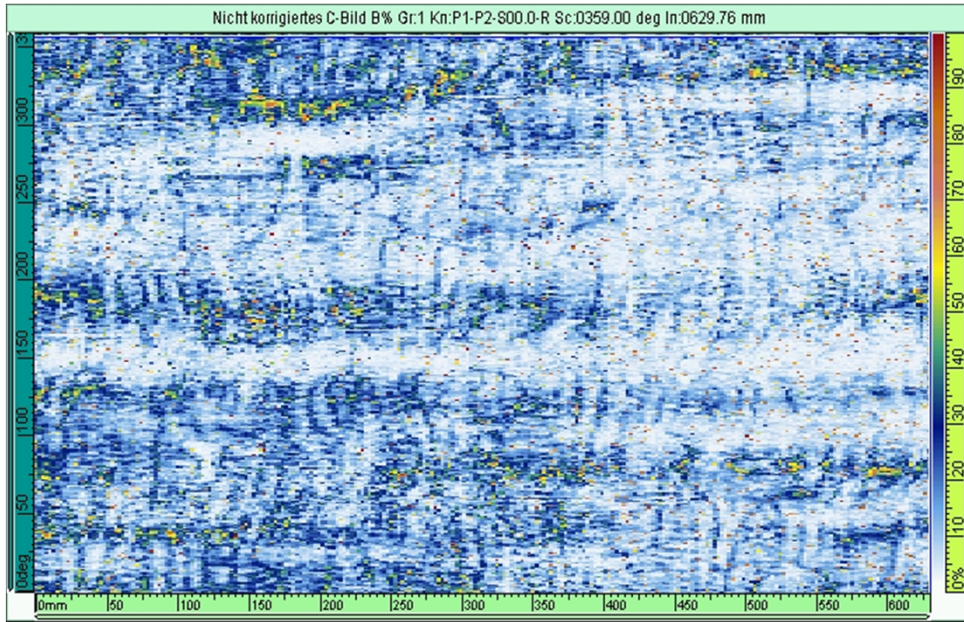
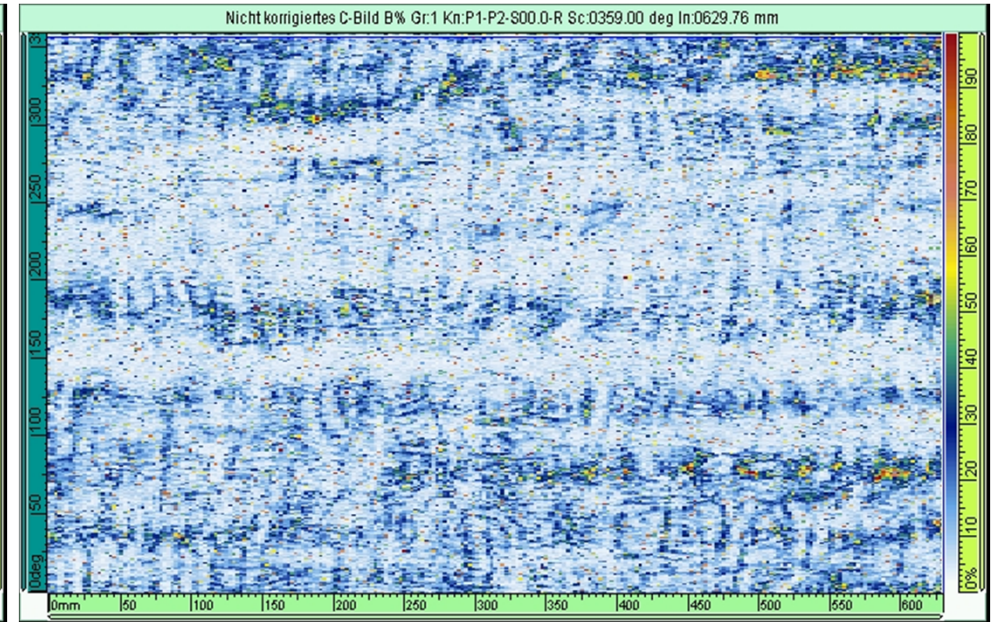
Results Joint V

- Done by automatic inspection.
- No indication for air void found.
- Liquid adhesive found.

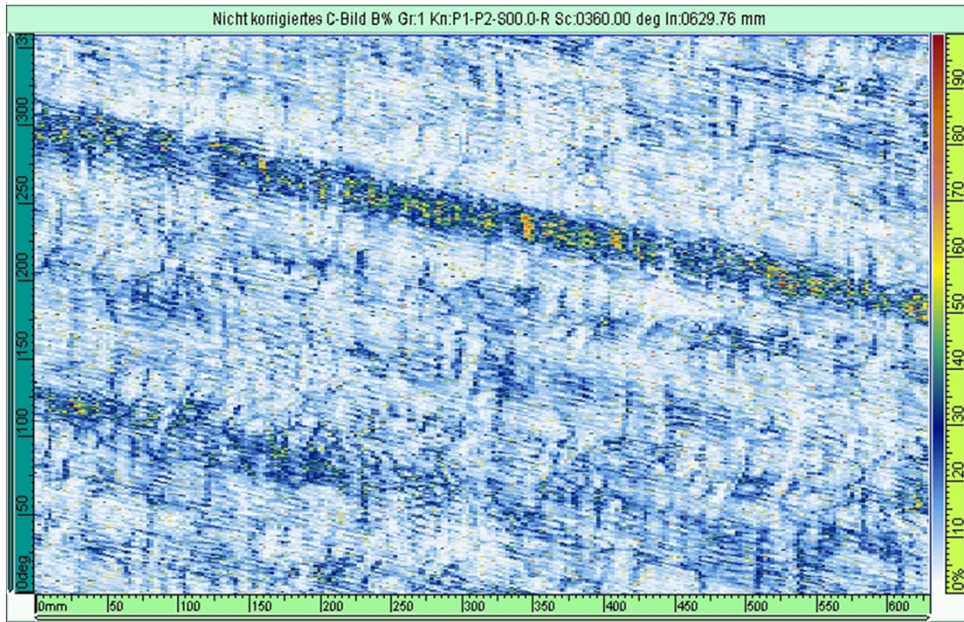
Results Joint VII

- Done by automatic inspection.
- No indication for air void found.
- Liquid adhesive found.

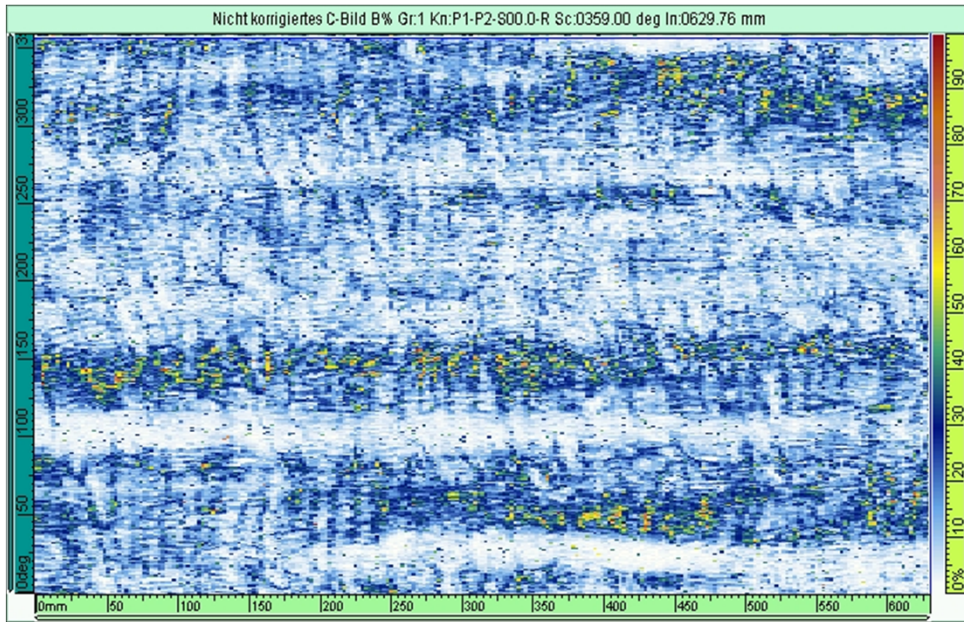
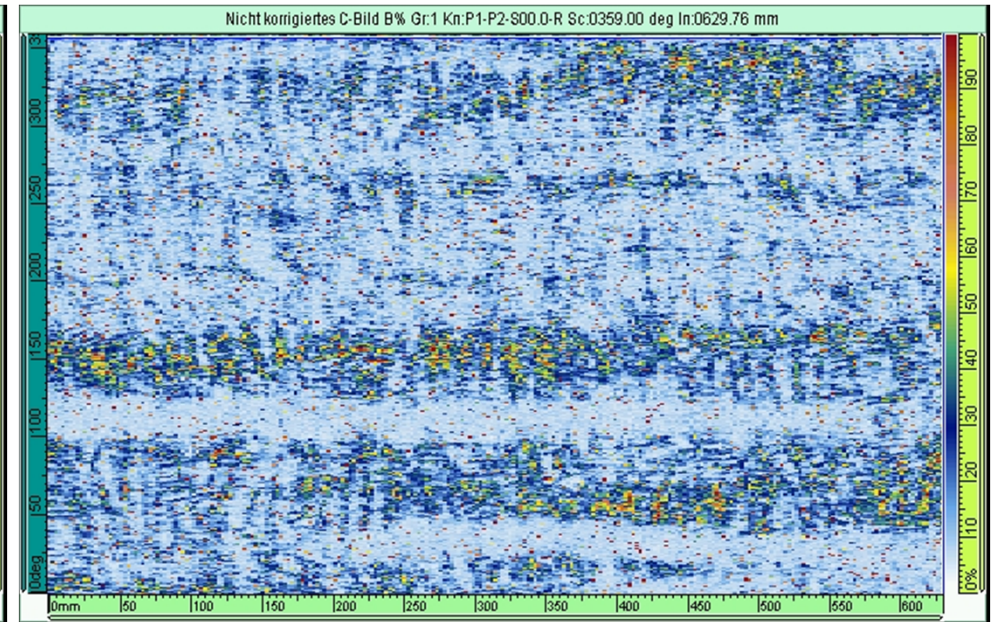
Results Joint VIII

- Done by automatic inspection.
- No indication for air void found.
- No liquid adhesive found.
