## **JoinTec**

Experimental Testing at SZMF

Fredensborg, 3rd June 2009

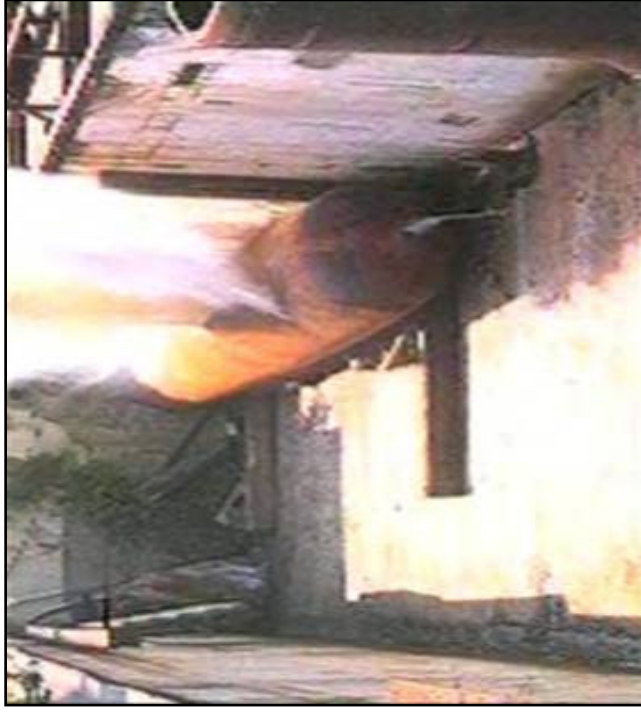
- 2 hydrostatic pressure tests with initial configuration accomplished (see Dr. Flügge)
- Dimensions  $\varnothing$  168.3 mm x 7.1 mm

- Computed burst pressure  $p_b = 320$  Bar
- Shear stress in adhesive @  $p_b = 320$  Bar  
 $\tau = 4.5$  MPa (<15MPa preliminary tests)

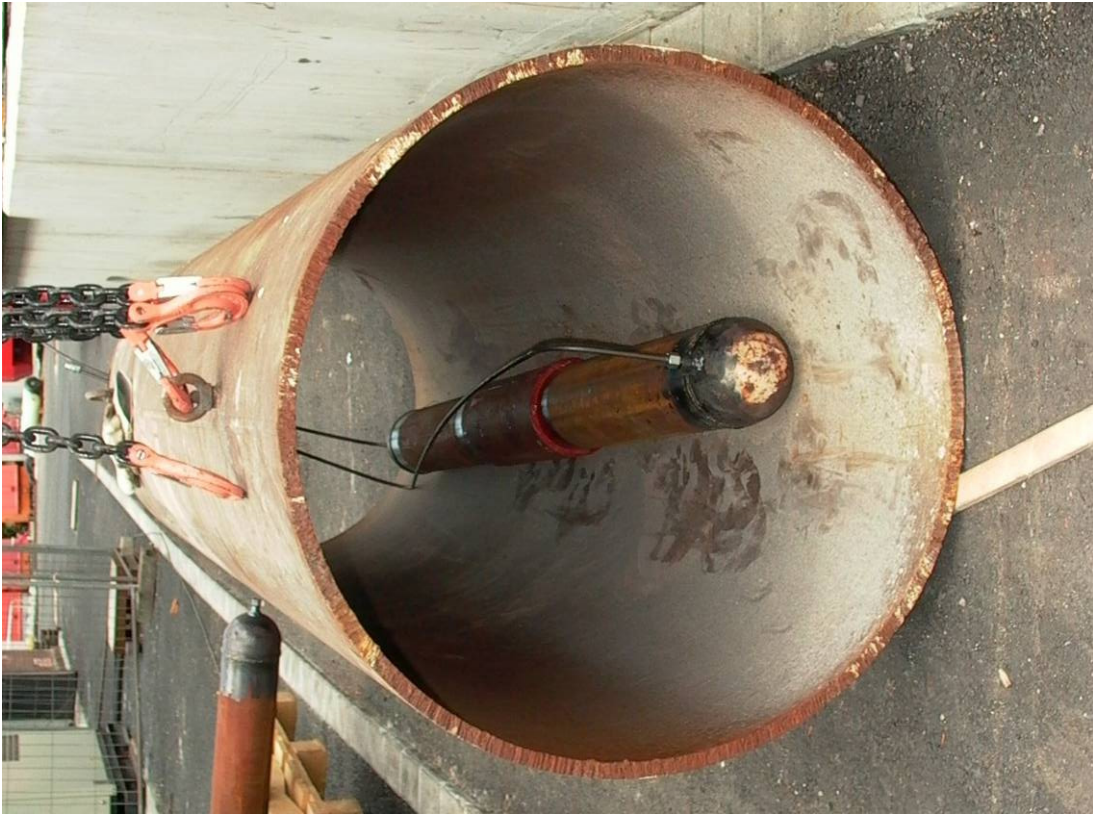
- Pipe closed with endcaps
- Specimen placed in protective tube
- Protective tube placed in burst pit

### Dimensions of specimen:

- Overall length 2000 mm
- Pipe Ø 168 mm x 7 mm
- Sleeve Ø 192 mm x 7 mm (manually manufactured)
- Sleeve length 500 mm (as required)
- Adhesive layer ~5 mm

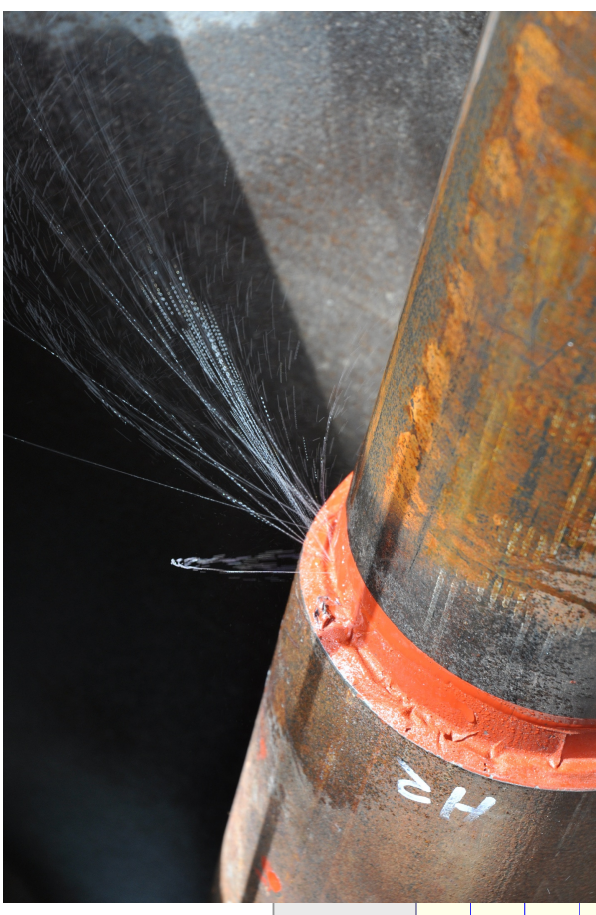
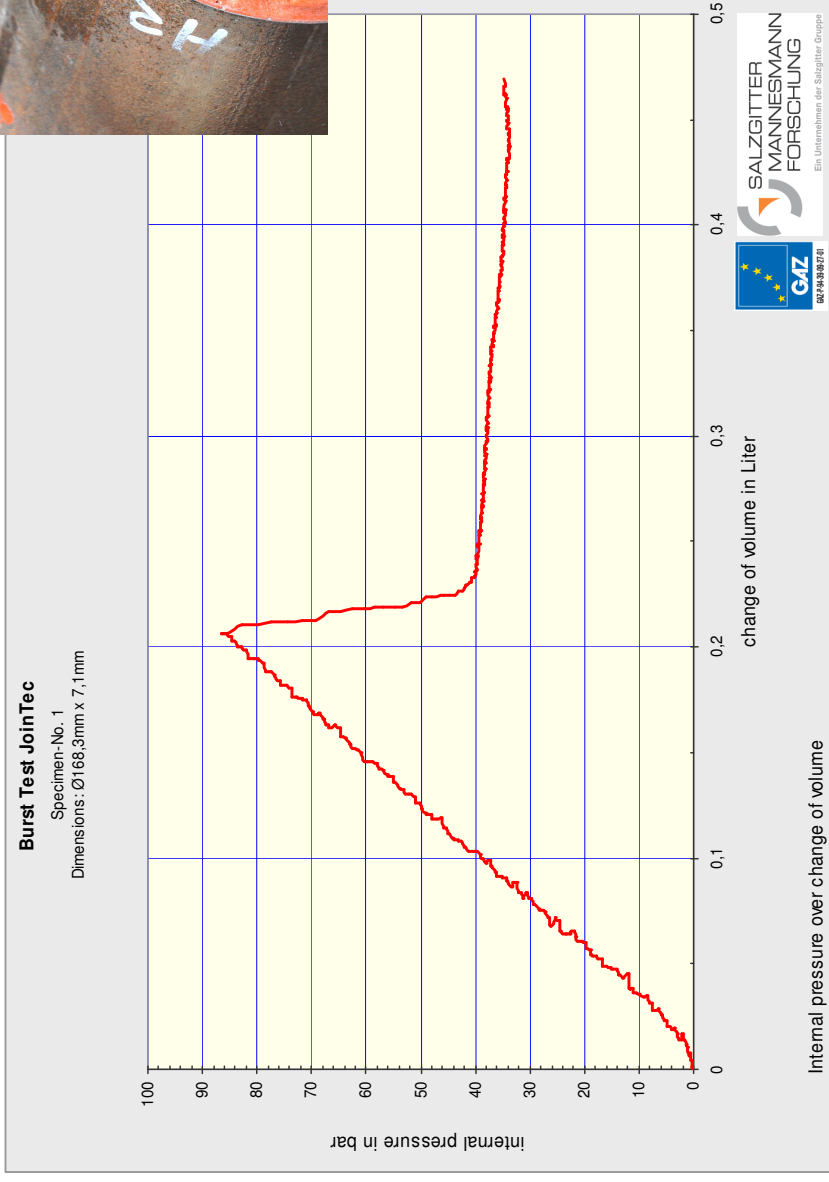
## Burst Test with 1st specimen

- Leakage in adhesive layer
- Max. pressure  $p_{\max} = 87$  bar

- $p_b = 320$  bar (comp.)
- $\tau = 1.23$  MPa @ 87 bar

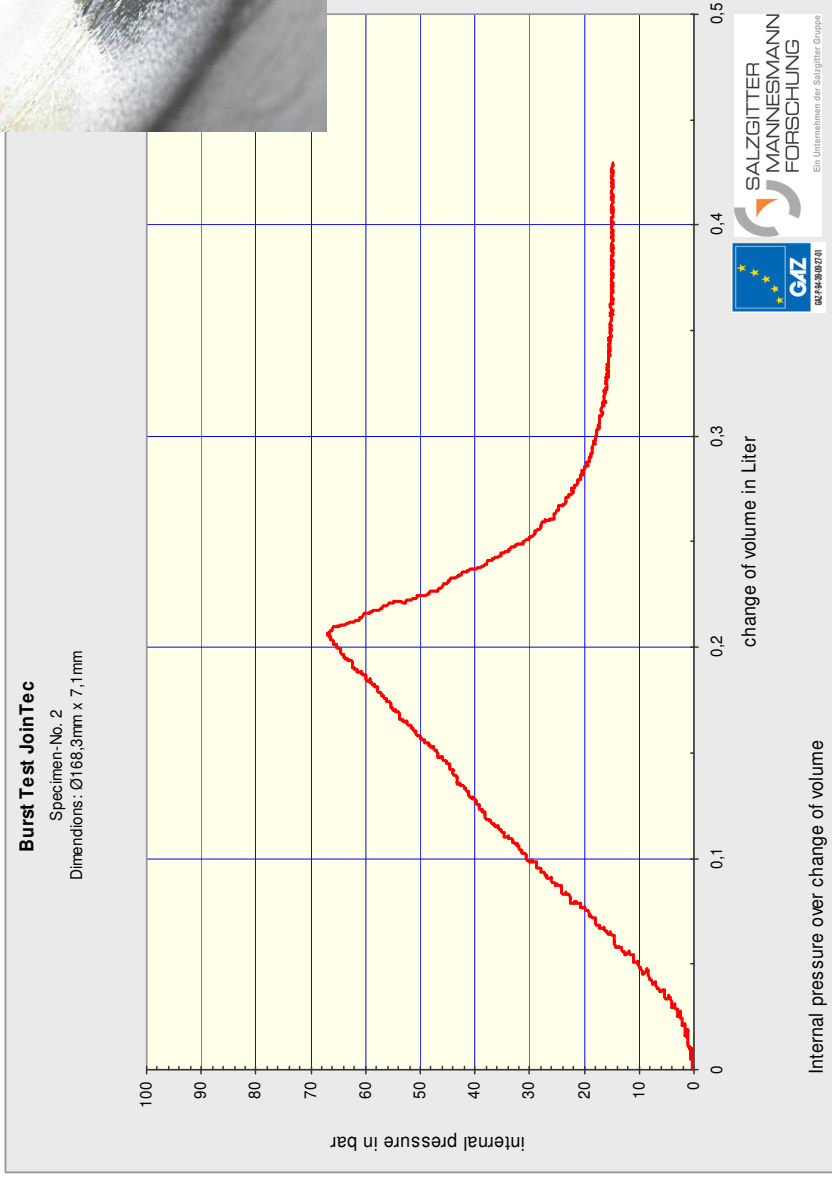
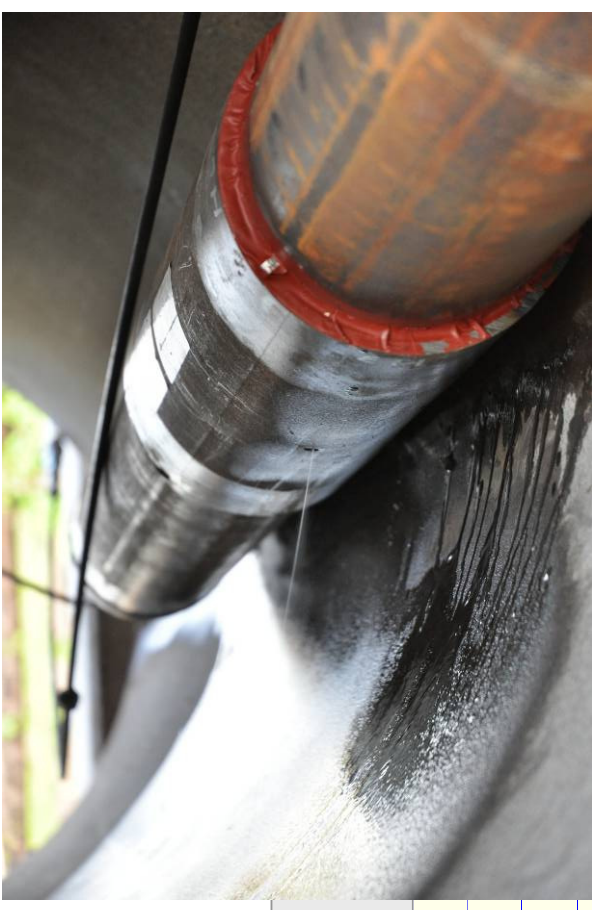
## Burst Test with 2nd specimen

- Leakage through borehole (vent)
- Max. pressure  $p_{\max} = 67$  bar

- $p_b = 320$  bar (comp.)
- $\tau = 0.95$  MPa @ 67 bar

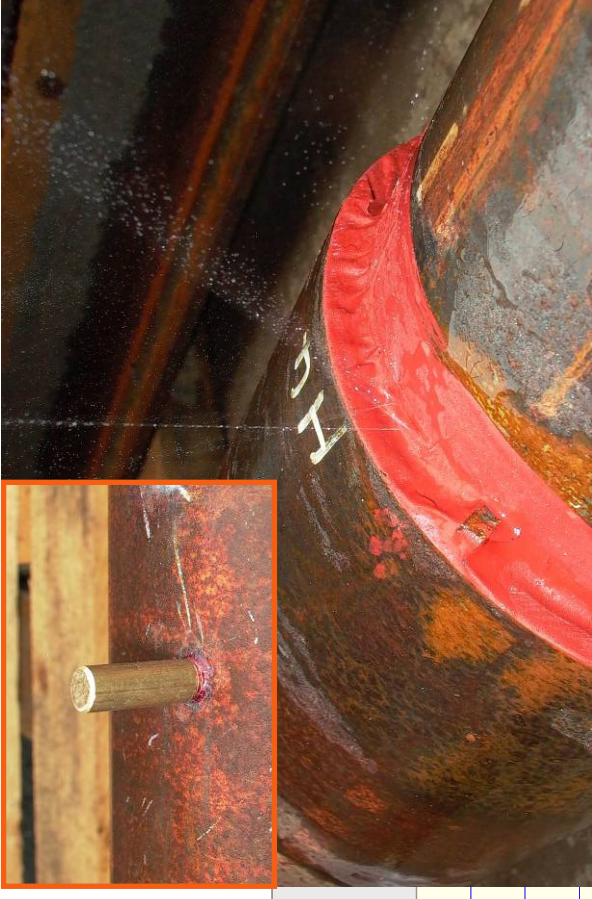
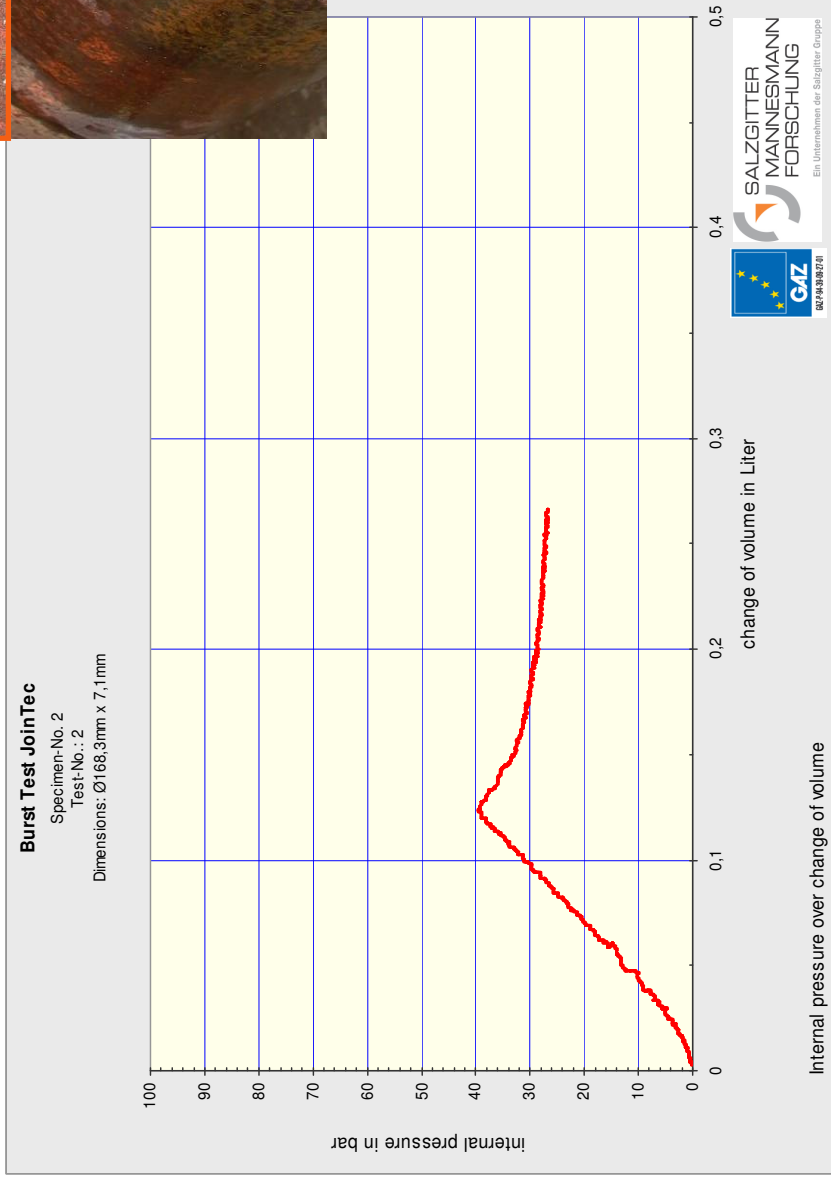
### Burst Test with 2nd specimen after sealing

- Borehole sealed with threaded plug
- Max. pressure  $p_{\max} = 40$  bar

- $p_b = 320$  bar (comp.)
- $\tau = 0.56$  MPa @ 40 bar
- Premature damage from first test

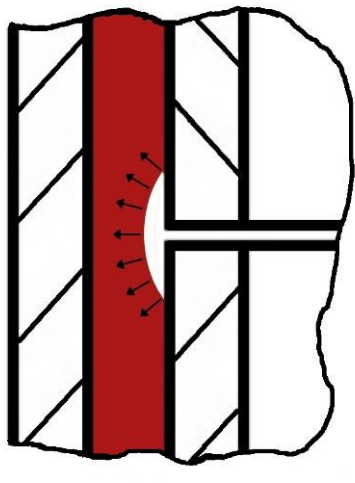
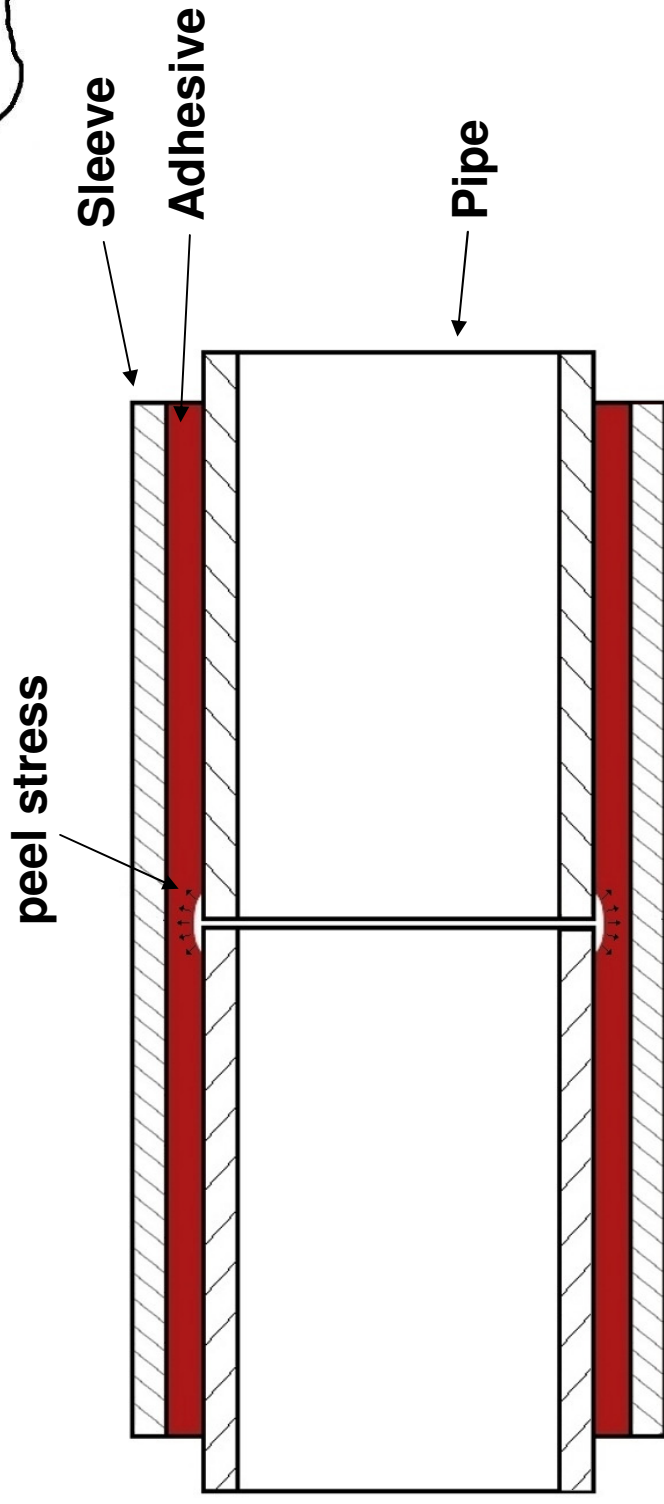
### Failure

- In adhesive layer
- Unfavourable load case for adhesive
- Water forces its way between adhesive and pipe

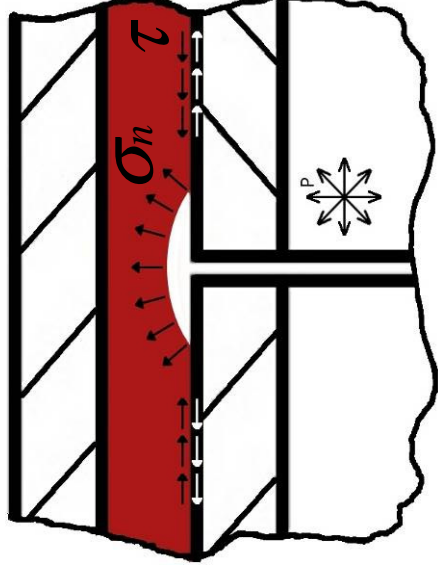
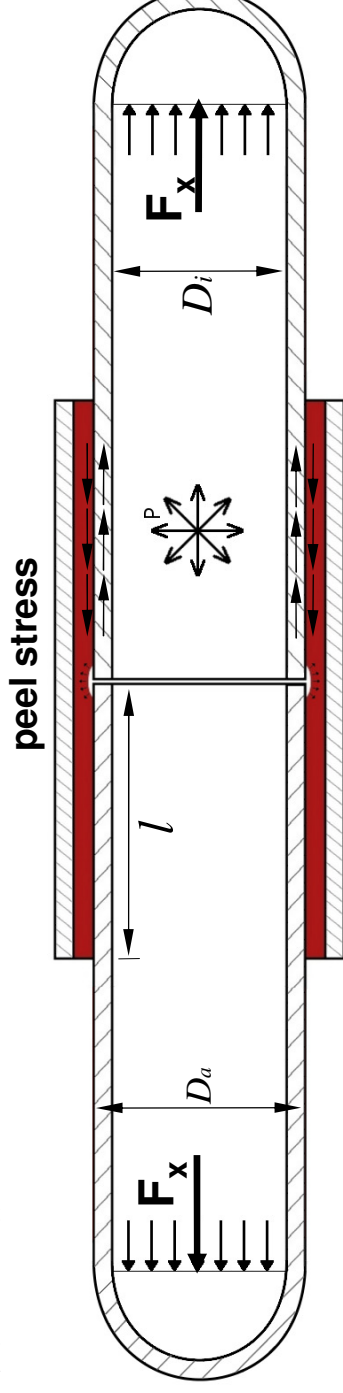
### Stresses in adhesive layer @ $p_{\max} = 87 \text{ bar}$

- Load Case: Axial Force

$$\tau = \frac{F_x}{D_a \times \pi \times l} = 1.23 \text{ MPa}$$

- Load Case: Direct hydrostatic pressure

$$\sigma_n = 8.7 \text{ MPa}$$

- Resulting stresses (von Mises):

$$\sigma_v = 9.0 \text{ MPa}$$

+ Adhesive layer contains non cured parts
