JoinTec

Paderborn, den 25. Mai 2010

Leaking pipe joints

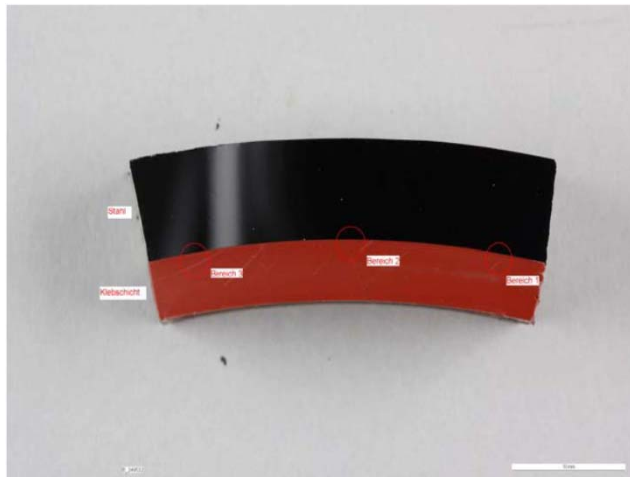
Bild 1
B_249532
Übersicht

Crack check

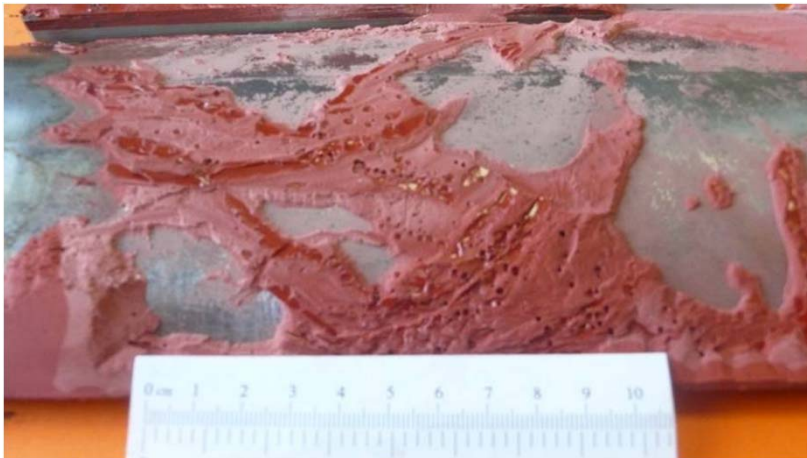
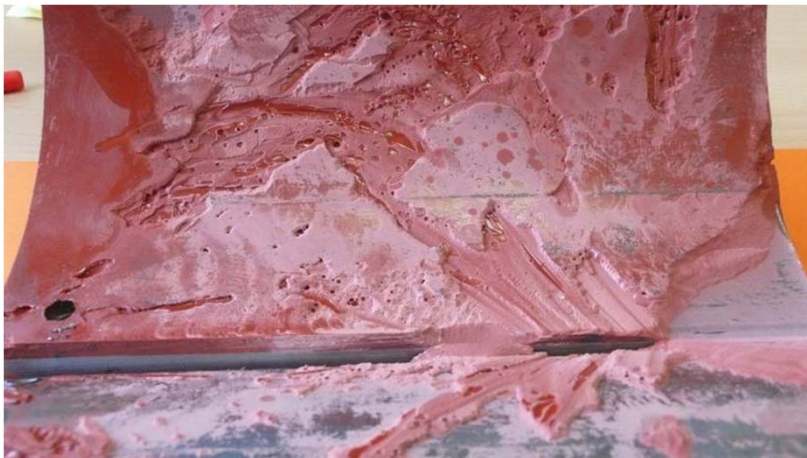
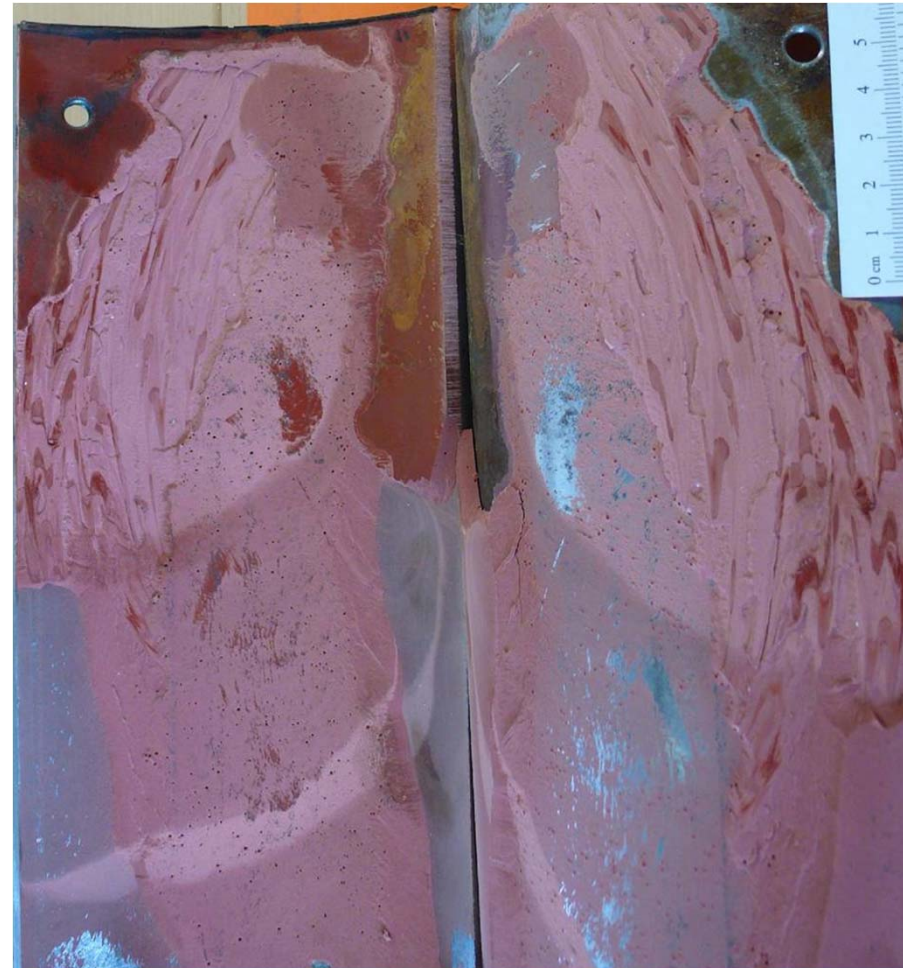
Not cured areas

- After 1 day: building of a hard surface
- After 6 day: liquid isocyanides is leaking out of the surface
- After 2 weeks:
 - Removing of the glass
 - Polyol next to the glass still liquid
 - Liquid isocyanides is crystalline
