Ultrasonic Inspection of adhesively bonded Joints

M. Kaack, Th. Orth

Paderborn , 26th / 27th of May 2010

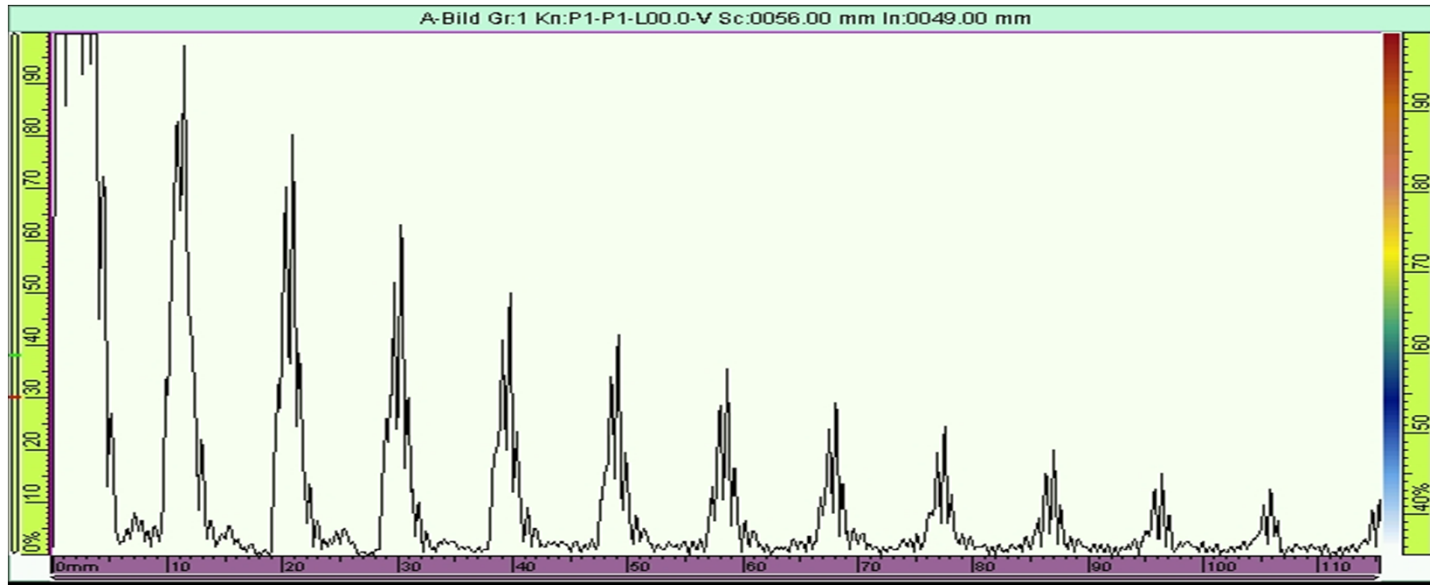
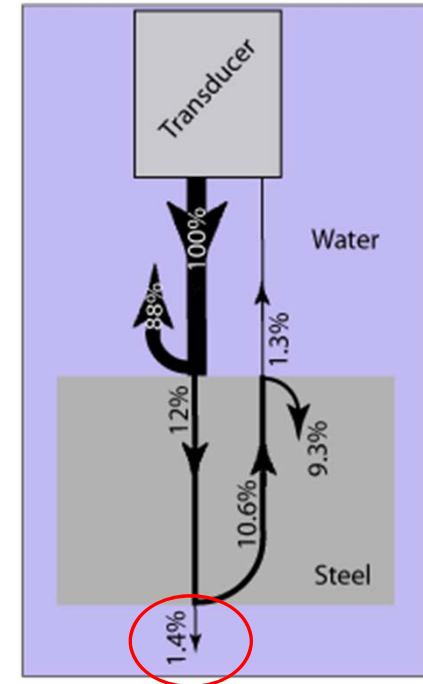
Attenuation in steel layer

- Here echo-amplitudes have to be evaluated.
- Echo trains at locations of void and adhesive are compared.
- Significant differences in attenuation is found!

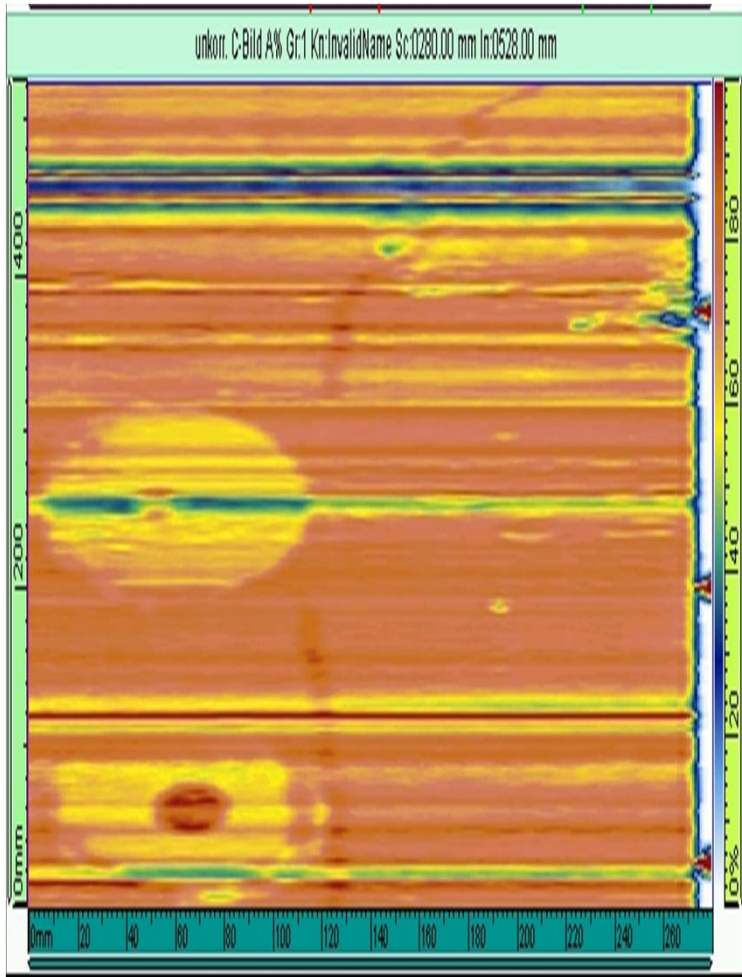
Piezo technique

In both techniques detection of the artificial defects is possible.

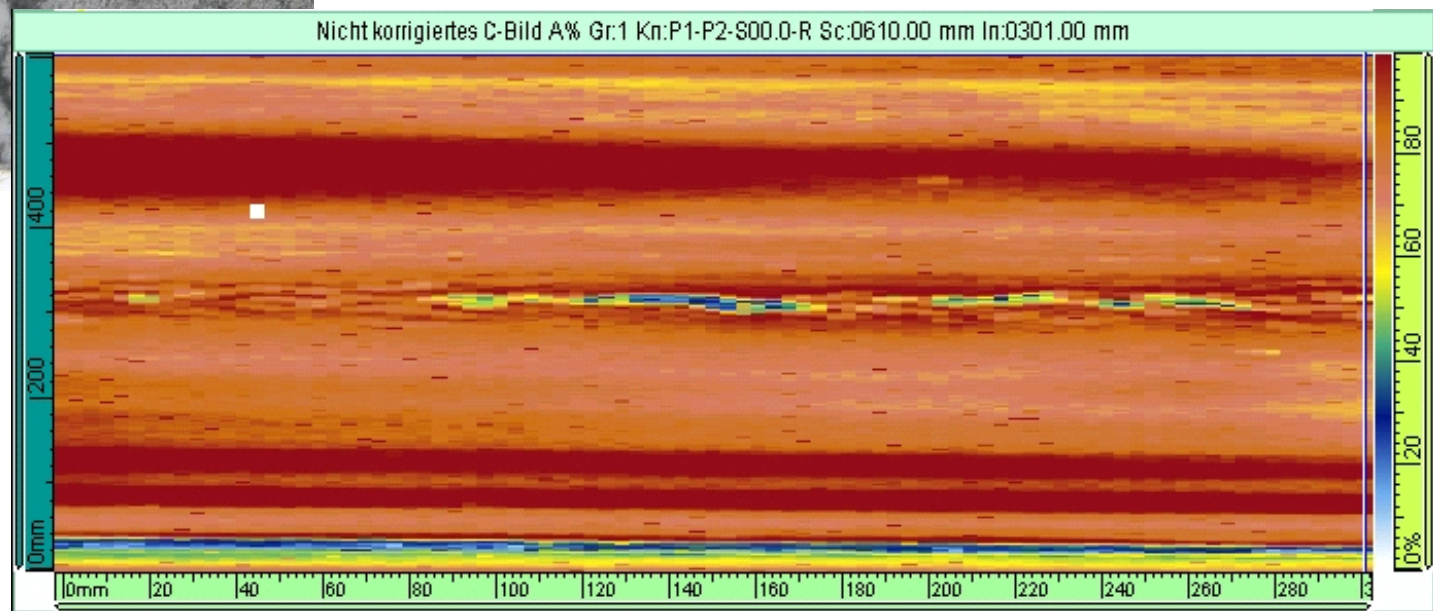
- Sleeves for 168 mm tubes have a 'corrosion line' opposite to the weld seam.
- These both lines lead always to UT-indications!

- To be placed in 3 o'clock and 9 o'clock positions.

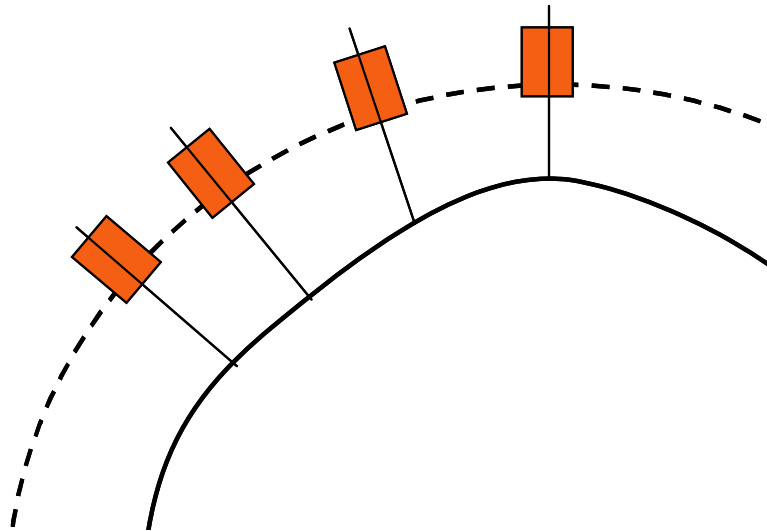
Piezo technique:

- Head ↔ surface distance is changing.
- Angle of incidence is changing.

Quality of the sleeve (roundness and smooth surface) are critical for the inspection!!

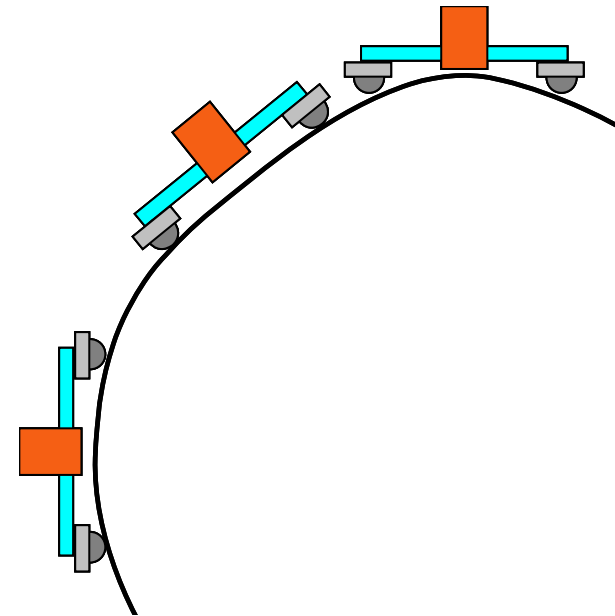
EMAT technique:

- Head ↔ surface distance is changing !!
- Double influence: magnetic forces and strength of eddy currents.
